Anatomy of a Lightning Strike

Paul McAllister
September 2004

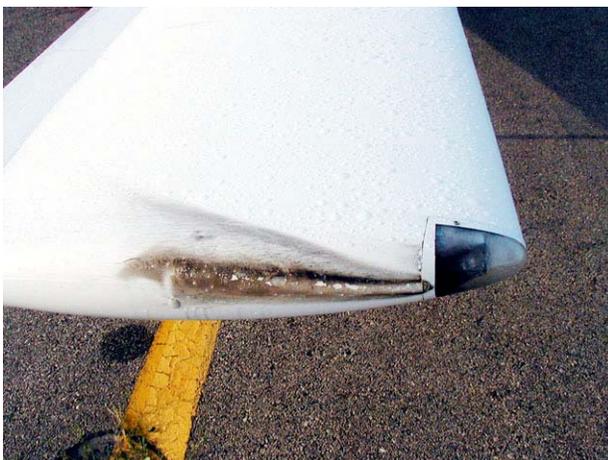
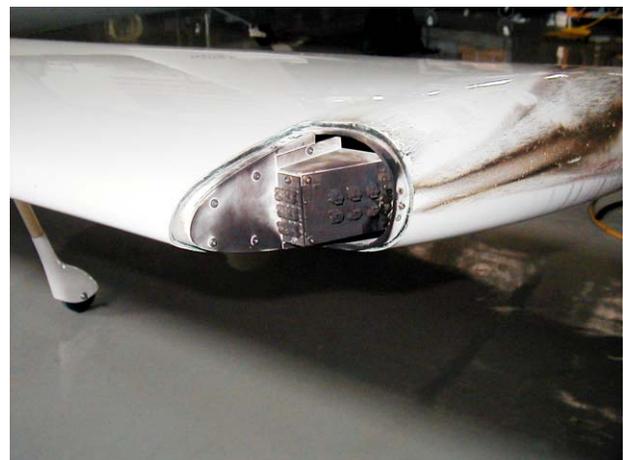
The panel went blank, and apart from the engine running things were quite. I looked out at both wings and saw long black training streaks on the tips. My first reaction was to check my 4 axis of control to ensure the aircraft was still flyable, which it was. I then surveyed the exterior for any other signs of damage, and none was evident. My next concern was electric fuel pumps continuing to run. I have my aircraft wired up with an E-Bus setup as described by Bob Nuckolls in the AeroElectric Connection. In addition, one fuel pump is connected directly to the alternator so I turned on the E-Bus and GPS / Radio along with the transponder sprang into life but nothing much else. I press the "Nearest" function but the GPS seemed pretty confused so I dug out my hand held. As luck would have it I was only a few miles away from an airport and with over 8000' beneath me I knew I even with the engine out I was fine.

The next day I unpacked the aircraft and started to survey the damage. The first thing I looked for was welding of the control mechanisms and I couldn't see any evidence of this. I pulled off the tip lights and looked inside the wings and I could not see any internal damage, nor was any evident in the inspection ports. It appeared that the conduction path was only along the navigation lights wiring. Surprisingly the wires seemed intact.
