**Federal Aviation  
Administration**

## ADVISORY CIRCULAR

# AVIATION MAINTENANCE ALERTS

**ALERT  
NUMBER  
388**

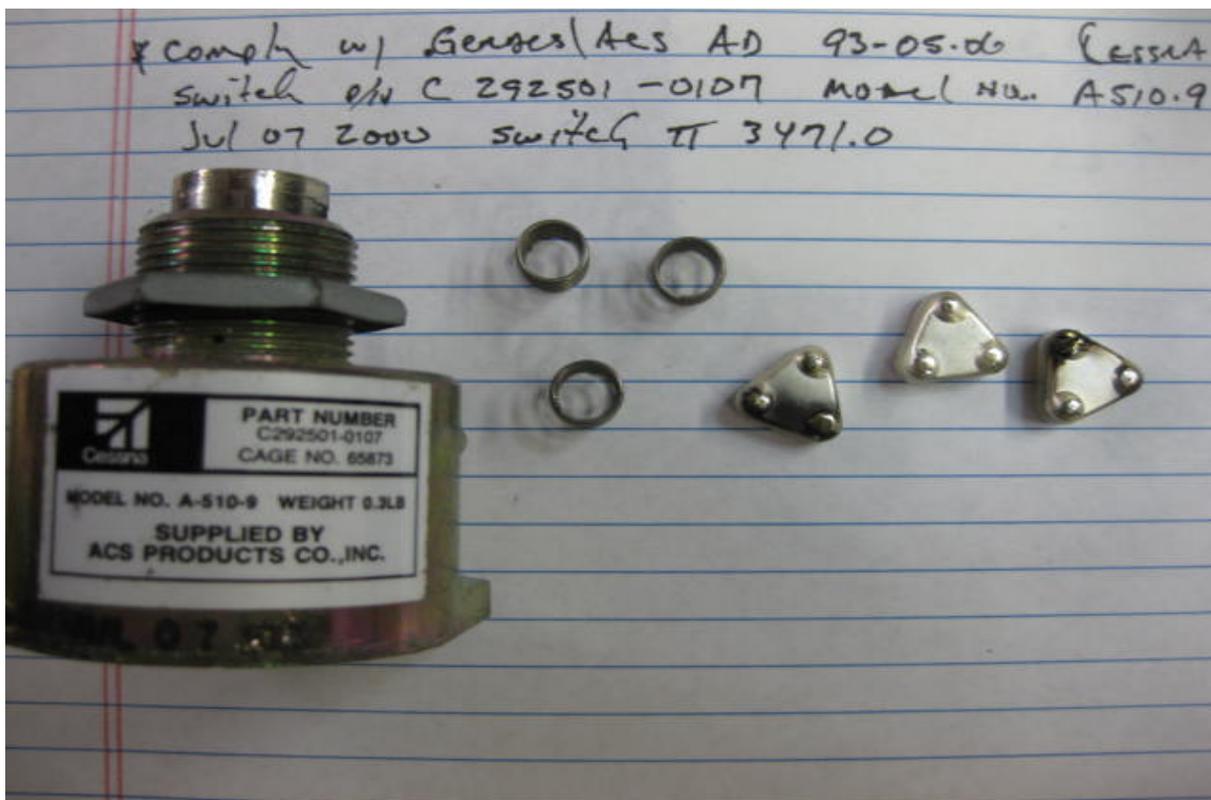
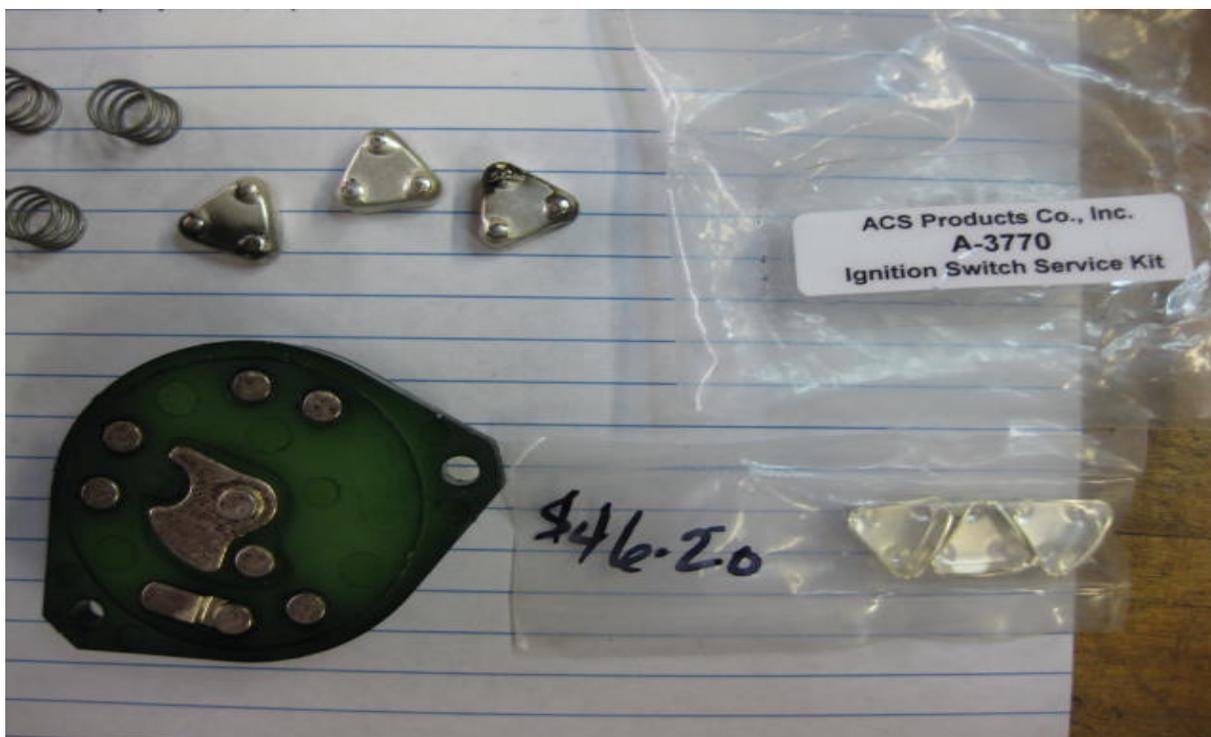
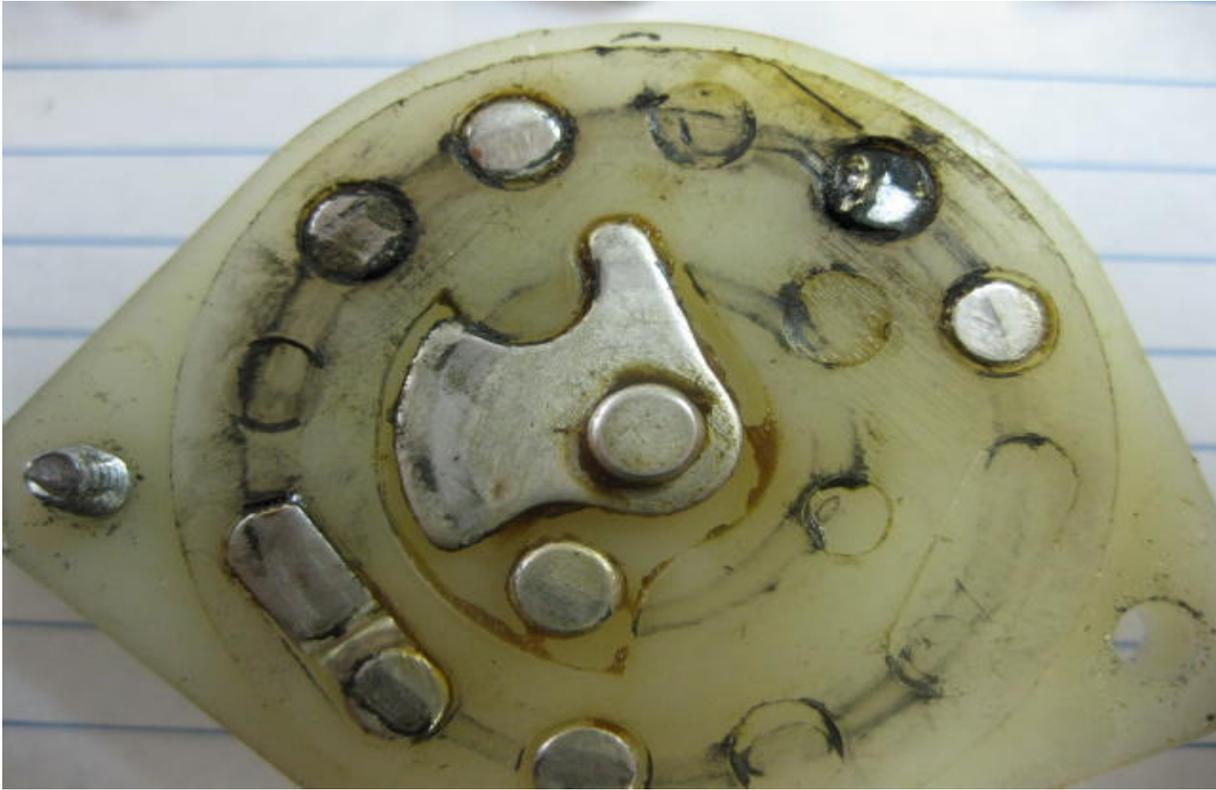
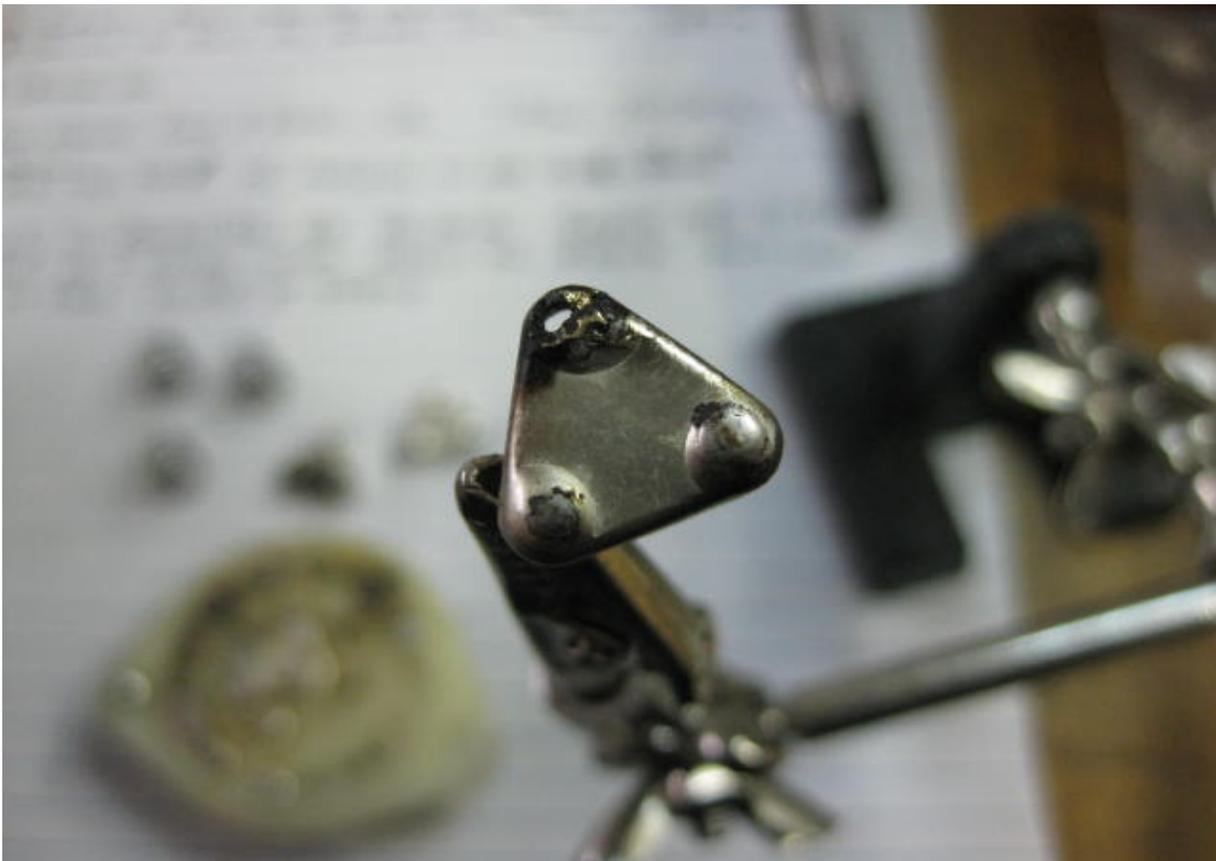
**Cessna: 172S; Failed Ignition Switch; ATA 7430**

A submitter states, "The ACS/Gerdes ignition switch (*on this aircraft*) has never been inspected in accordance with Cessna SEB91-5R1 (*bulletin*) to comply with Airworthiness Directive 93-05-06. Upon disassembly of the switch, the circuit board plate was found to be severely worn, and one contact point was burned. (*This*) contact cup was burned completely through, creating a hole in the contact point. The screw heads holding the body of the switch to the terminal board assembly were painted red—as required by SEB91-5R1 and as described by identification of a factory new switch. However, there was no visible grease on the cups or the circuit board. Discussions with other mechanics and inspectors (*causes*) me to believe this AD is overlooked due in part to mechanics assuming no AD exists for switches manufactured after 1993. The text of the Airworthiness Directive as well as the text in SEB91-5R1 and ACS Service Bulletin SB92-01 do not support this assumption. I have three other aircraft of the same vintage (Cessna 172S) due for inspections in this shop with no documentation of Compliance with this recurring AD."

*(P/N: C29250107. Slight photographic deformation is due entirely to this editor's manipulation. Great admonition! Thank-you for your very concise effort—Ed.)*

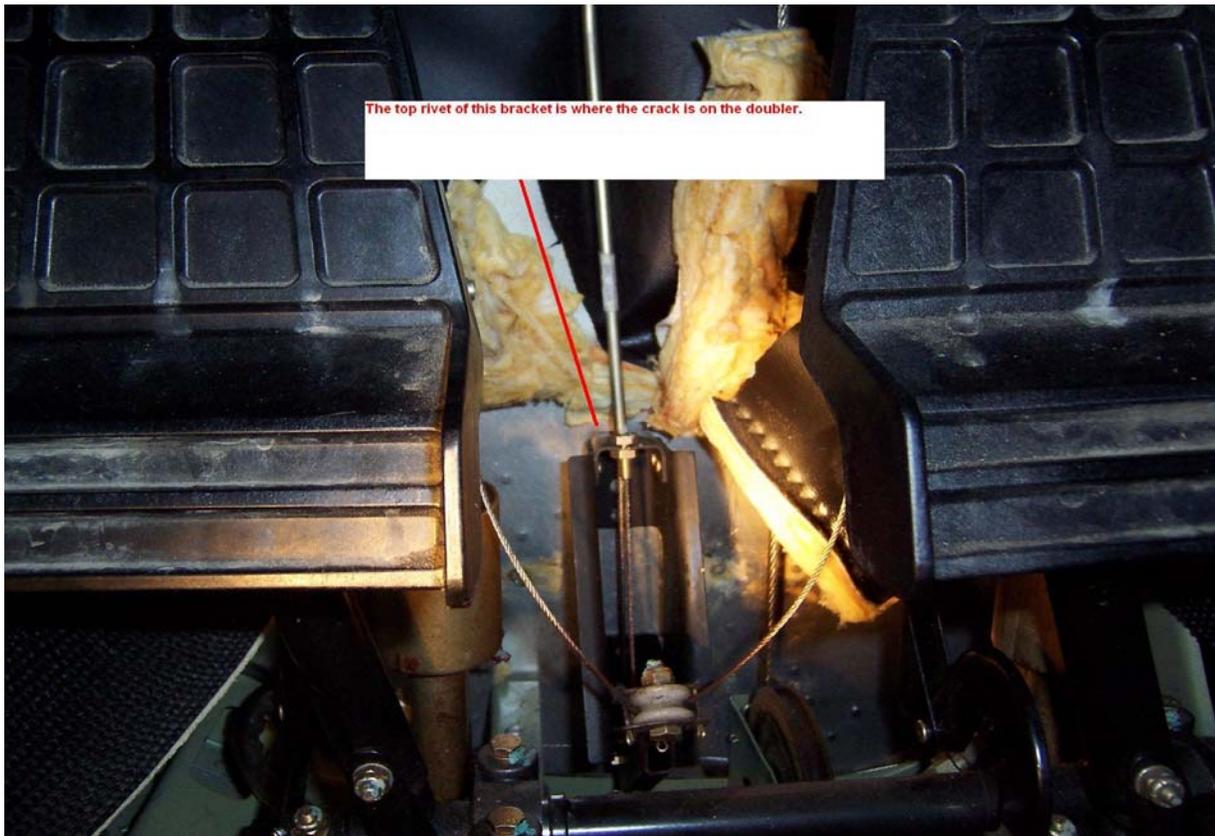
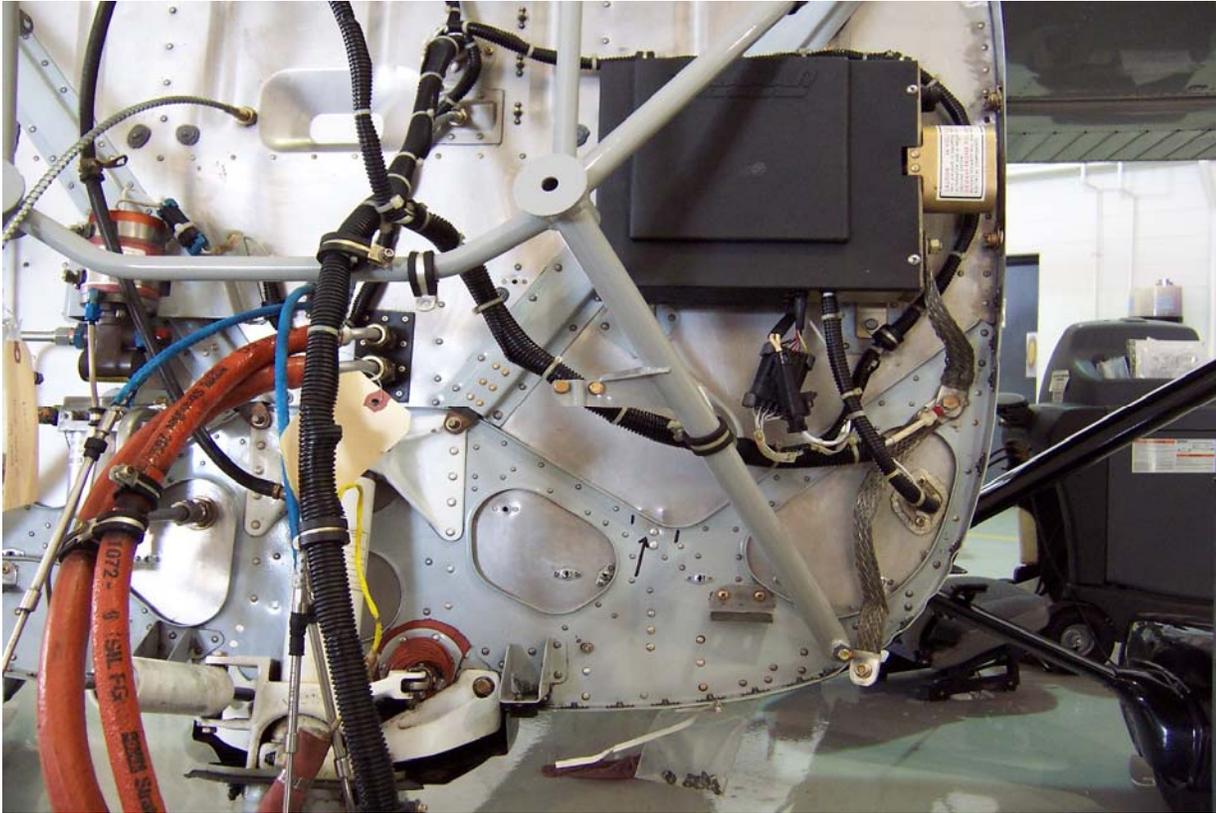
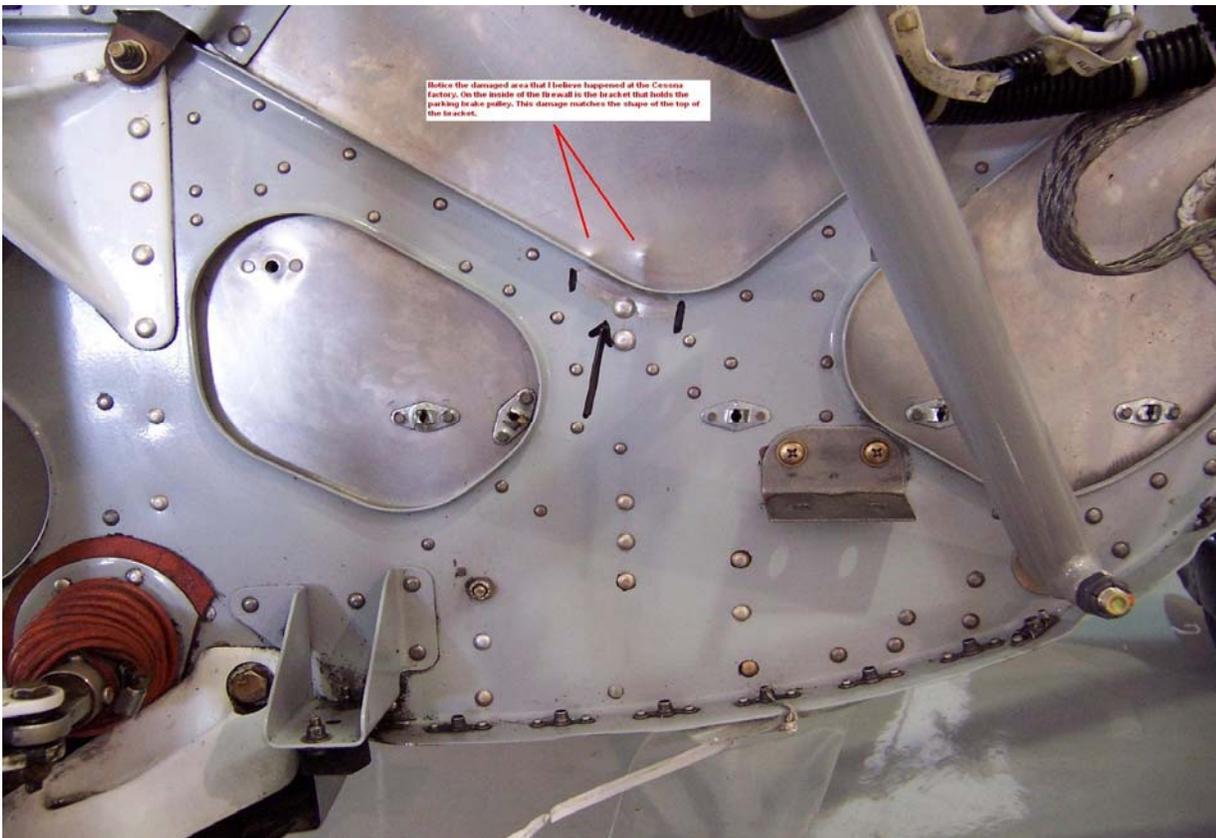
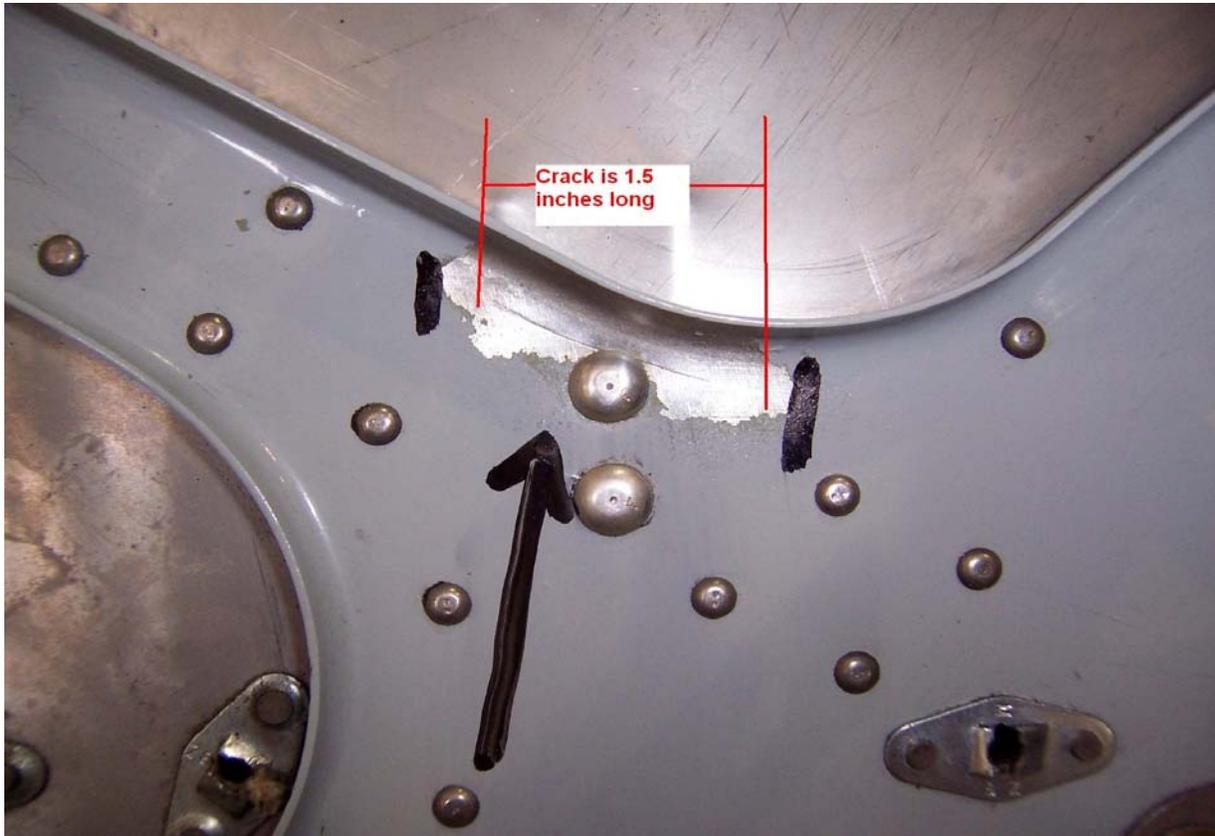
### **Cessna: 182S; Cracked Firewall Doubler; ATA 5412**

"A 1.25 inch long crack was discovered in the firewall forward doubler (P/N 0753600-24)," says this technician. "The crack location can be found by locating the 'Bracket-Parking Brake Control' aft of the firewall. (See Cessna 182S IPC Revision 19, Chapter 32-32-02; figure 01, item #38; P/N 0713070-20.) Translate this location to the forward side of the firewall. The crack was centered around the top rivet attaching the 'Bracket-Parking Brake Control' to the firewall and firewall doubler.

"When the parking brake handle is pulled, this area of the firewall and firewall doubler flex a little. It is very probable this flexing action has caused this crack in the firewall doubler. Two small dents can be seen in the firewall from the 'Bracket-Parking Brake Control.'"

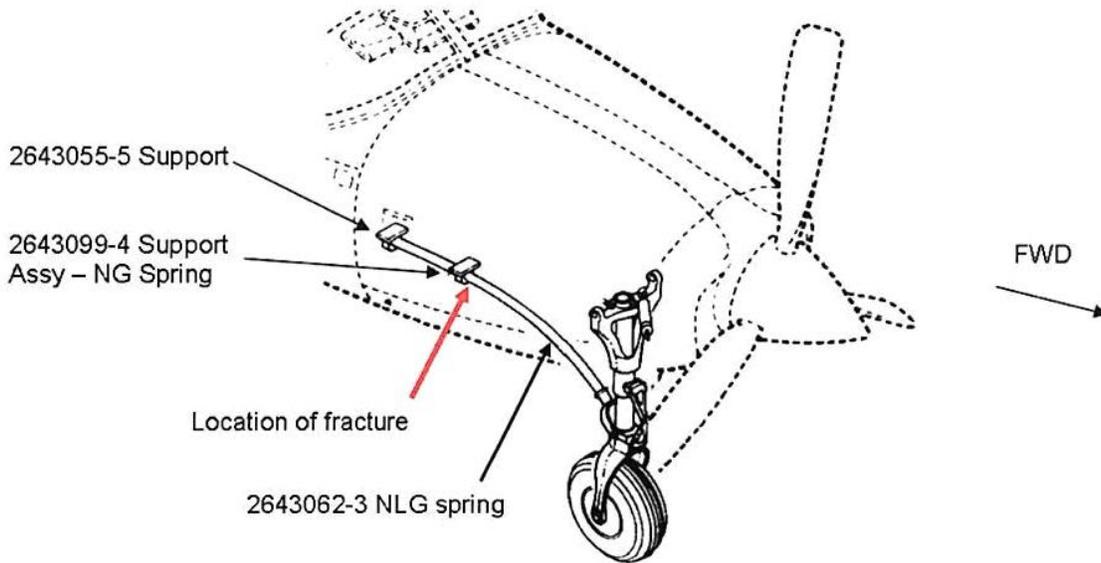
The schematic in Figure 1 shows the location of the fracture relative to the Support Assembly (P/N 2643099-4). Photo 2 is a magnified view showing the chevron pattern indicating the origin of the fracture at the lower outside diameter of the NLG spring. Photo 3 presents a tilted magnified view showing pitting corrosion along the outside diameter that coincides with the origin of the fracture. Photo 4 depicts a longitudinal metallographic cross-section through the origin of the fracture showing the corrosion pitting.

**Figure 1: Location of the fracture relative to the Support Assembly (P/N 2643099-4).**

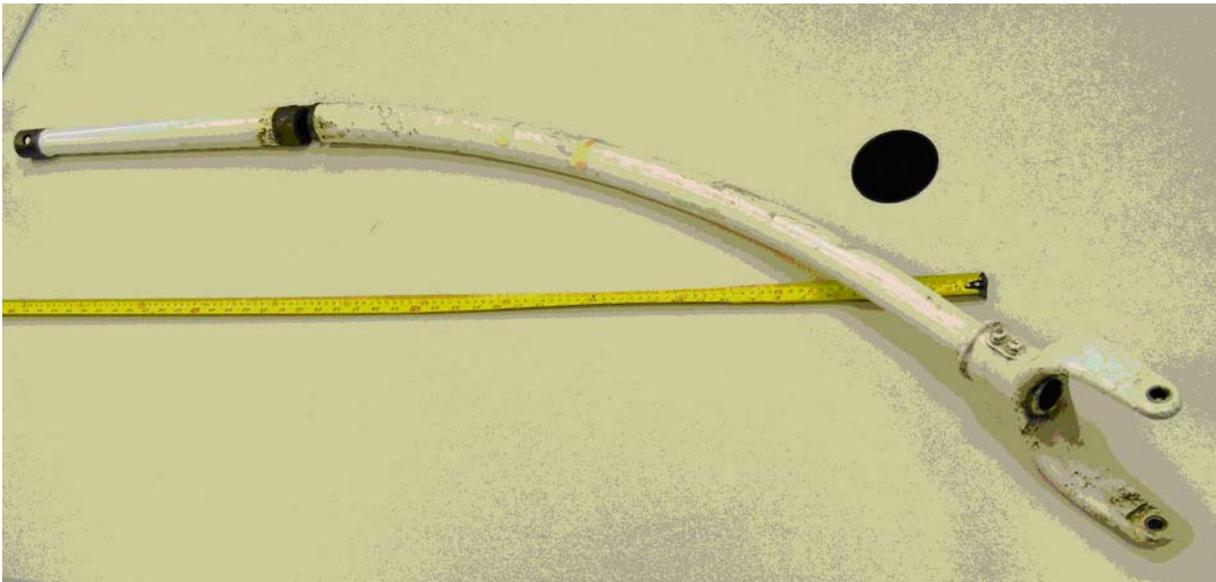
The FAA Wichita ACO received a Cessna 208 broken nose landing gear spring (P/N 2643062-3) shown in Photo 1. Installed on the airplane in December 2004, this NLG spring fractured during a landing in Puerto Rico in May 2010. It had nearly 3,000 flight hours. The fracture was analyzed and the following conclusions were identified: (1) Significant corrosion in the area of the fracture origin was present at the outside diameter of the NLG spring with pit depths slightly exceeding 0.02 inches; (2) stress-corrosion cracking was observed to a depth of nearly 0.02 inches, followed by ductile overload.

**Photo 1: An overall view of the broken NLG spring.**

The Corrosion Prevention and Control Inspections found in the Cessna Maintenance Manual (5-30-01 &-02) require reoccurring visual inspections of the NLG for evidence of corrosion. The inspection information from the manual for mild or moderate corrosion (airplanes without TKS anti-ice system) is shown in the Table 1. For severe corrosion (airplanes with TKS anti-ice system), divide the inspection intervals in this table by two.

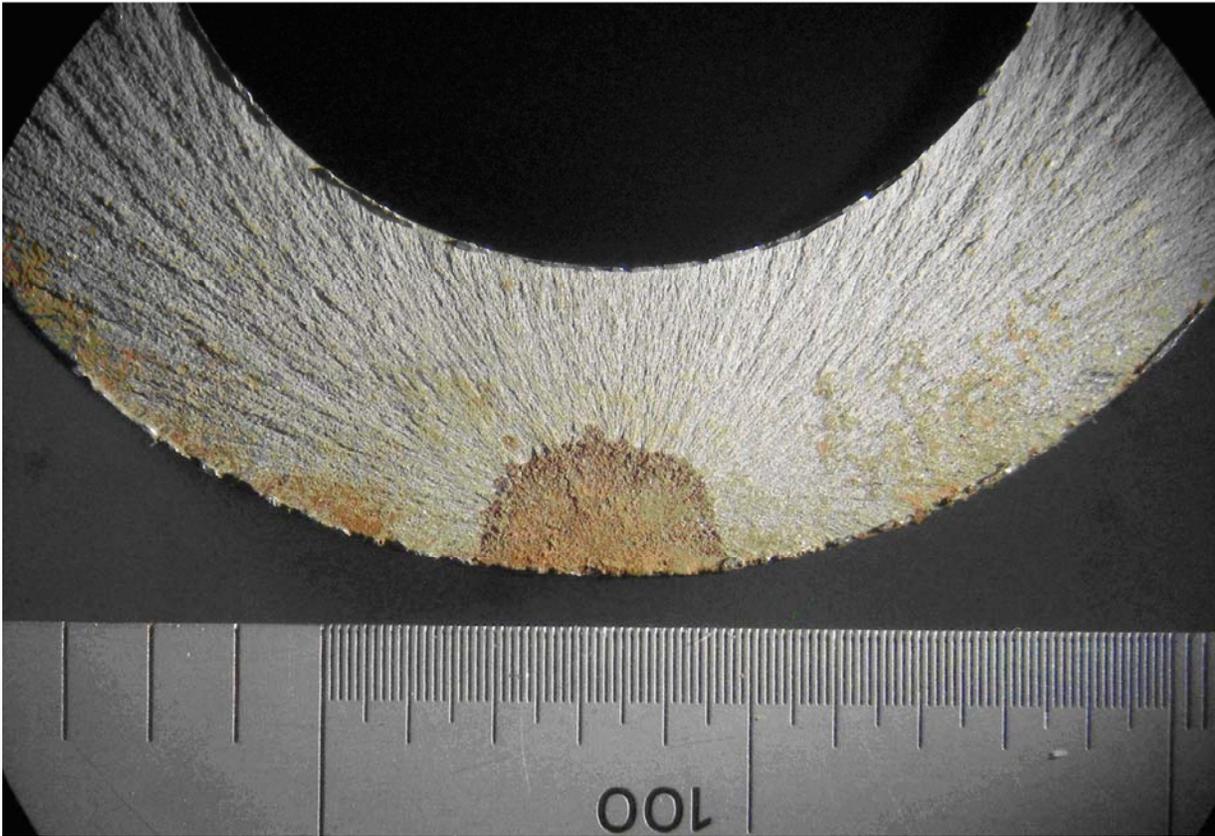
**Photo 2: A magnified view of the fracture surface showing the chevron pattern at the origin of the fracture.**

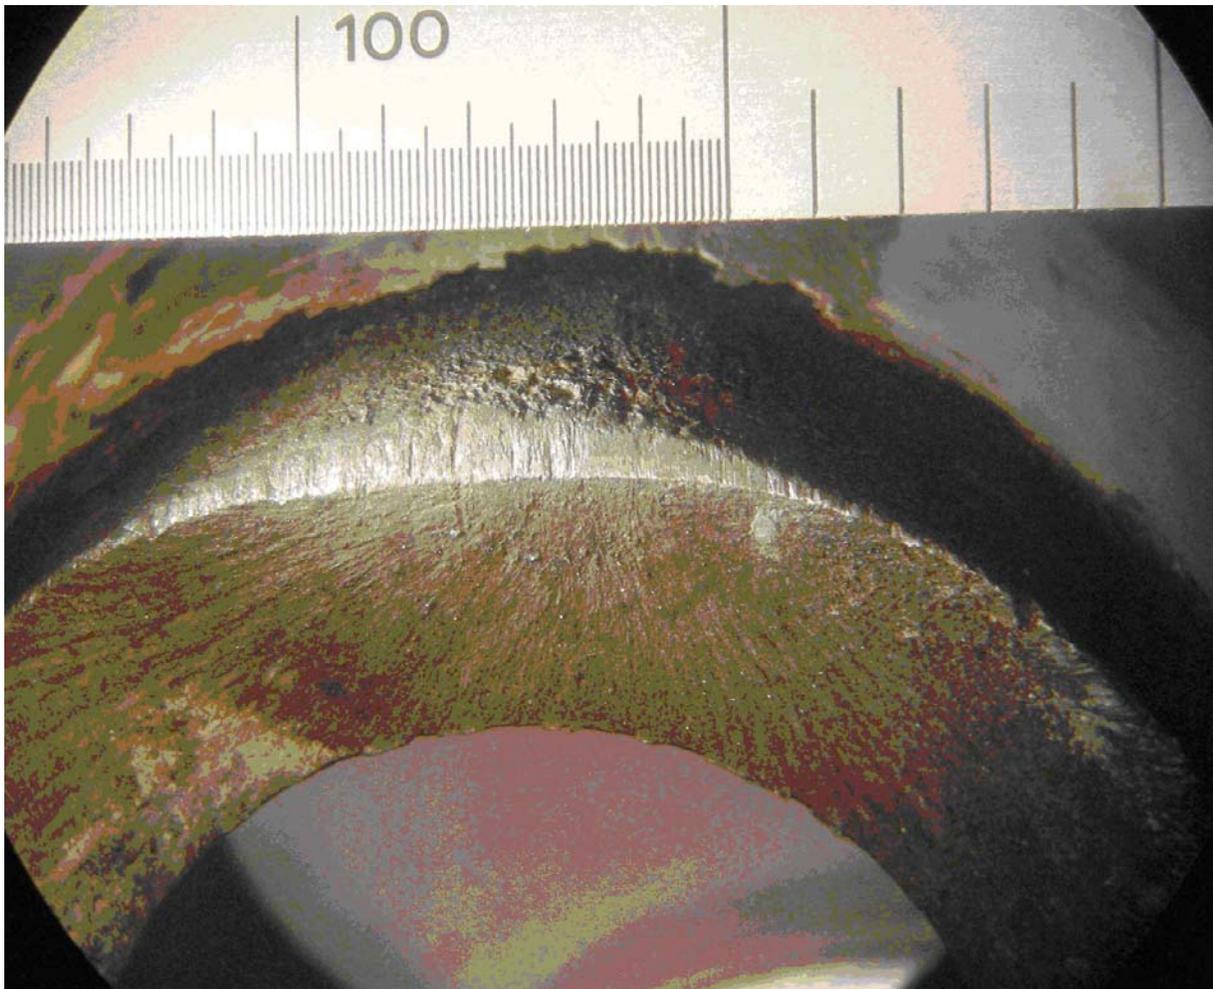
**Photo 3: A tilted magnified view of the fracture surface showing pitting corrosion coincident with the area at the origin of the fracture.**

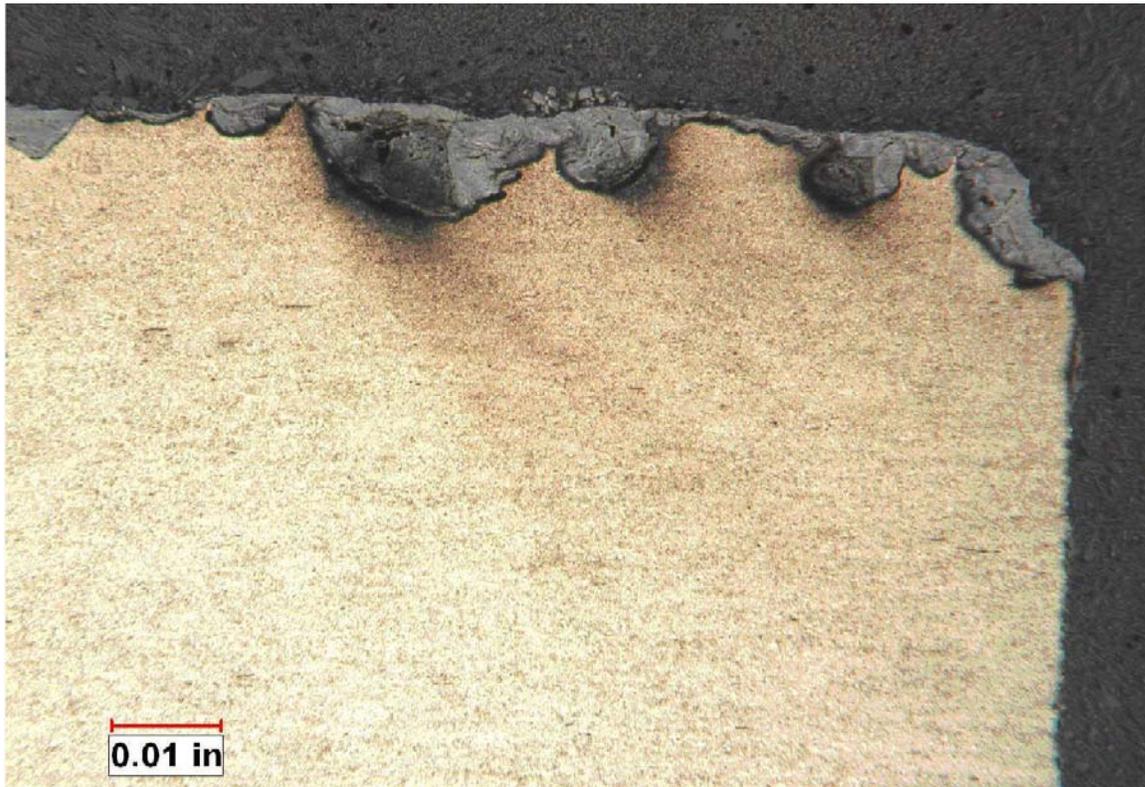
**Photo 4: This view depicts a longitudinal metallographic cross-section through the origin of the fracture showing the depth of the corrosion pitting.**

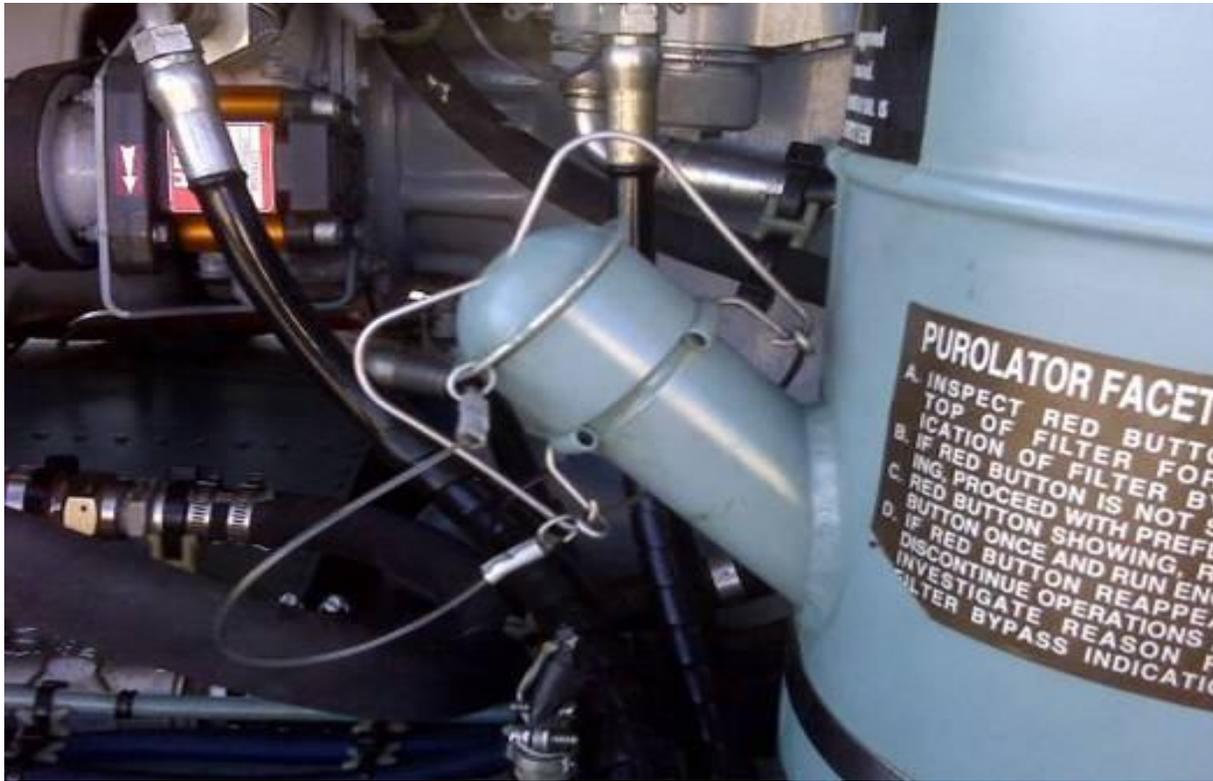
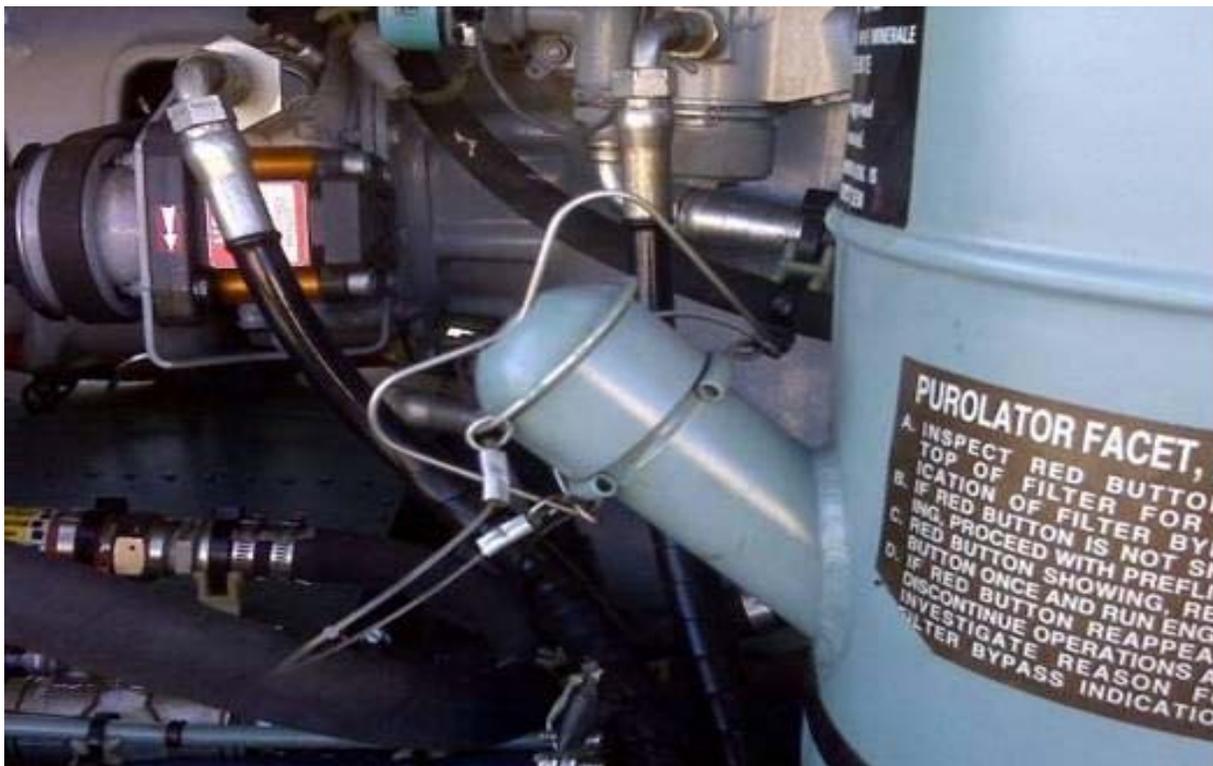
**Eurocopter: AS350; Loose Oil Reservoir Cap; ATA 7261**

"The engine oil reservoir cap came off in flight," says this submitter, "resulting in significant oil loss. The helicopter returned to base with no problems encountered. (*At*) issue is Eurocopter's 'unique' retaining mechanism for the oil cap. (*This*) retaining mechanism is easily dislodged, and yet still appears to be locking the cap into place. Unless you are specifically looking at the retaining mechanism during a preflight—and you know what it is suppose to look like when it is in the locked position—it can be easily overlooked. (*I*) recommend Eurocopter devise some type of safety device for their retaining mechanism. Also, this (*item*) should be added to their 'Before First Flight' checklist."

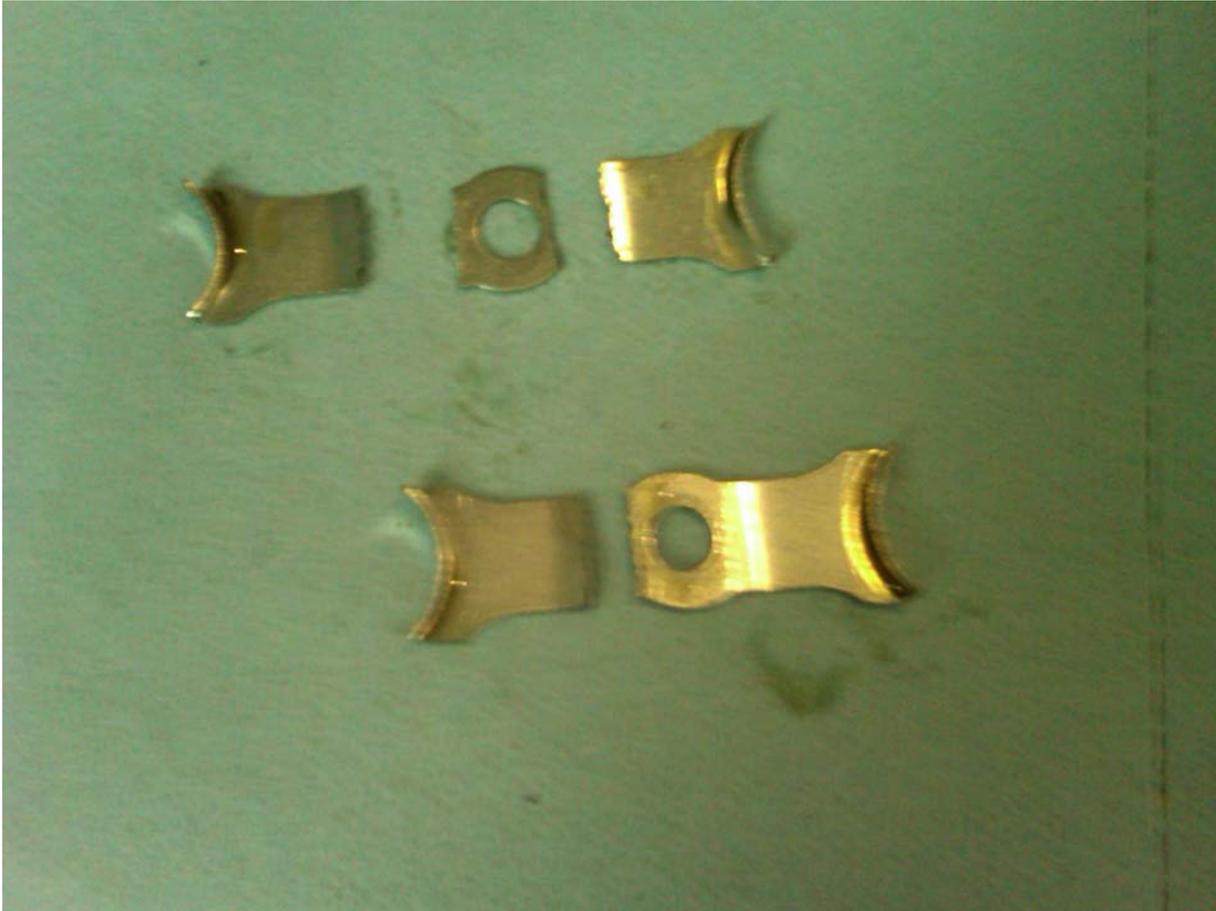
### Lycoming: O540; Failed Pushrod Shroud Springs; 8530

A technician states, "Tracing an oil leak, it was discovered the pushrod shroud tube retaining springs (SL14995) had failed on all six cylinders. The part failed by breaking into two or more fragments. This allowed the shroud to unseat from the head and leak oil. All six springs were replaced." *(There are eight similar reports in the SDRS database.)*

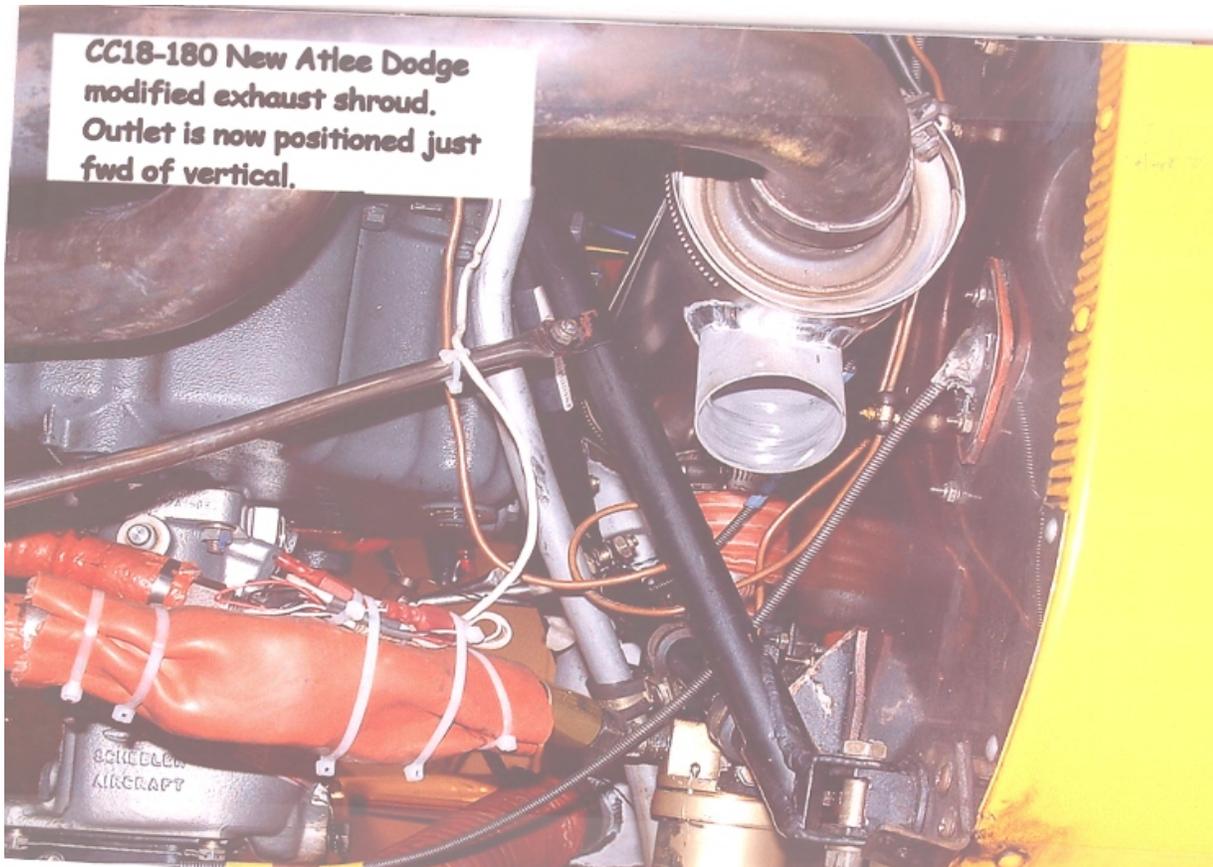
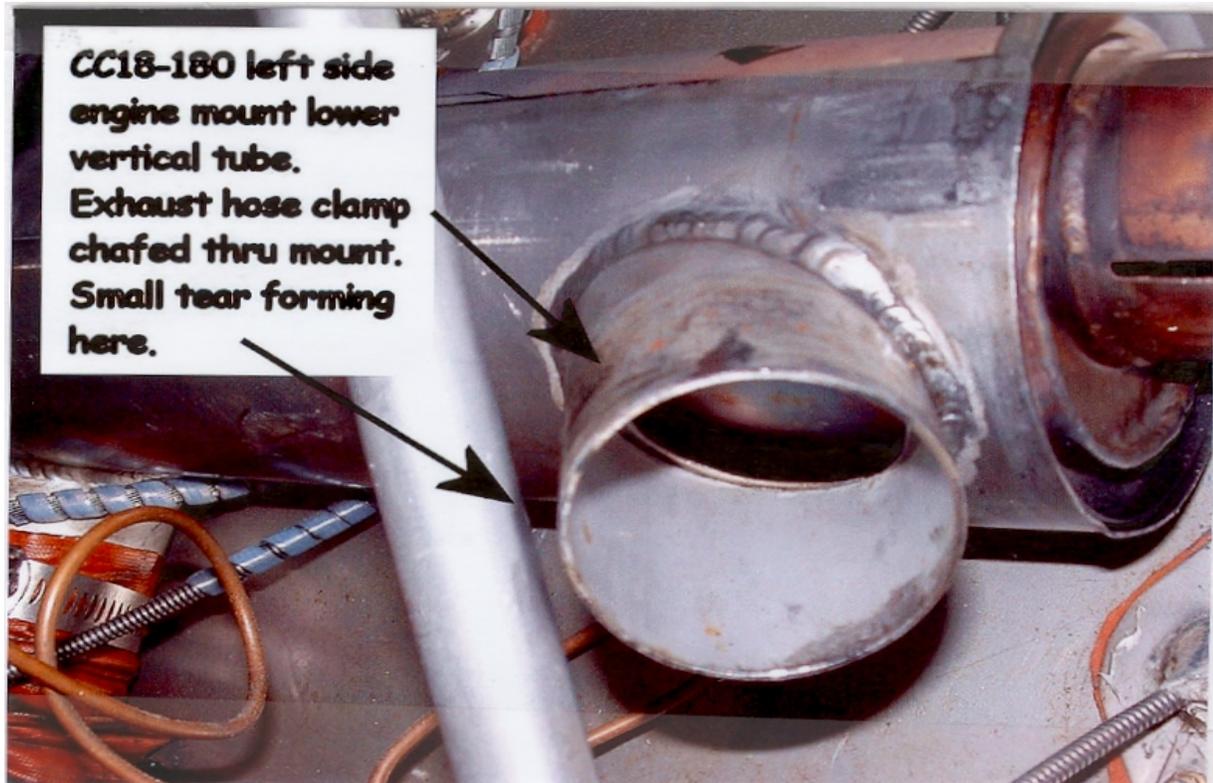
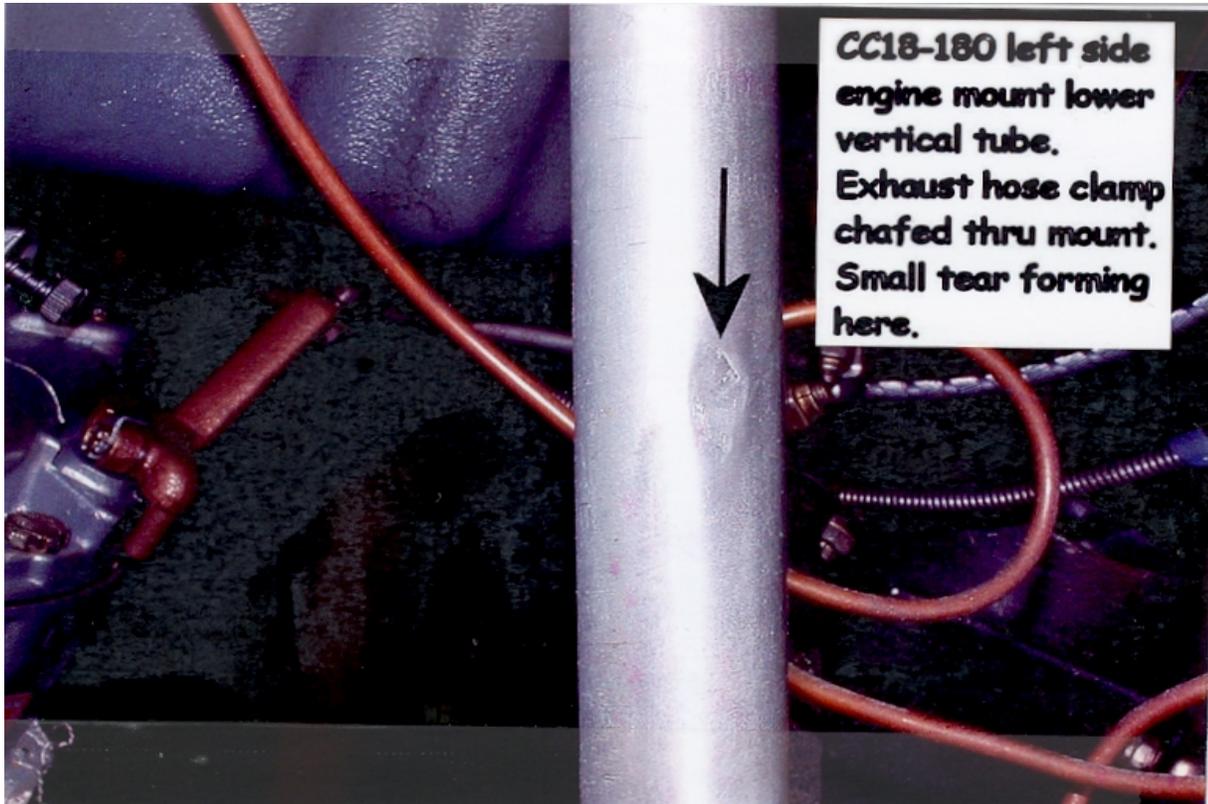
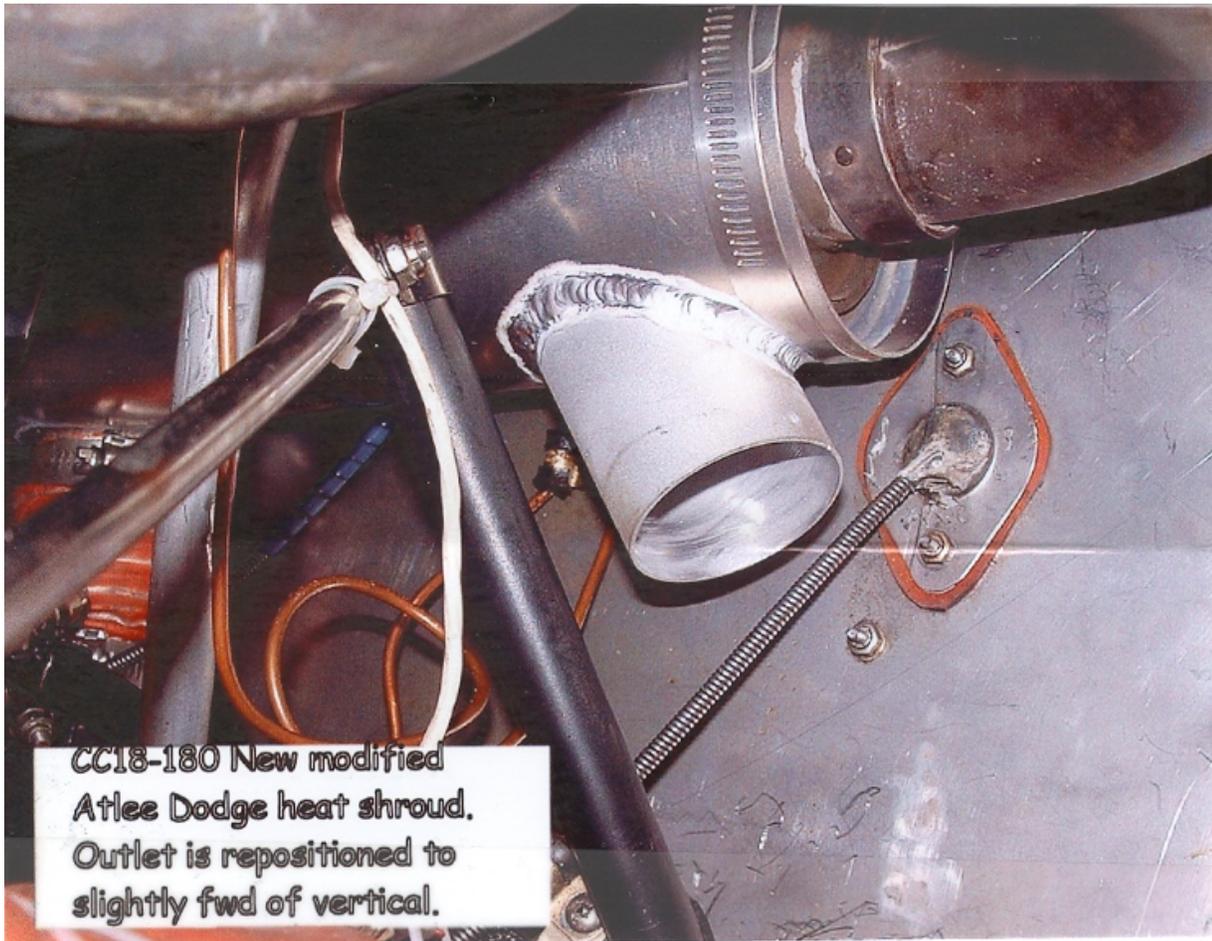
*(The following description references a Lycoming O-360-C4P bolted to a Cub Crafter CC18-180).*

An aviation inspector says, "I removed the aircraft muffler (Atlee Dodge P/N 3241) to perform the muffler inspection and found the hose clamp on the muffler shroud's left cabin heat inlet port had worn a notch through the engine mount's lower left vertical support tubing (Univait P/N 12351-15). A small crack had formed in the top of the notch in the tubing. There was insufficient clearance between the heat shroud and the engine mount, and the shroud hose clamp would vibrate against the mount when the engine was running. When viewed from the left side of the aircraft the original inlet was clocked at about the 8:00 position. We fabricated a new shroud with the inlet clocked at *(approximately)* the 6:15 position, and now there is ample clearance. Refer to the attached pictures for reference. I would recommend checking all CC18-180's for this issue, and replace the shroud with a modified shroud. This shroud had worn the hole in the *(engine)* mount within 1400 hours total time."
