**Federal Aviation  
Administration**

## ADVISORY CIRCULAR

# AVIATION MAINTENANCE ALERTS

**ALERT  
NUMBER  
388**

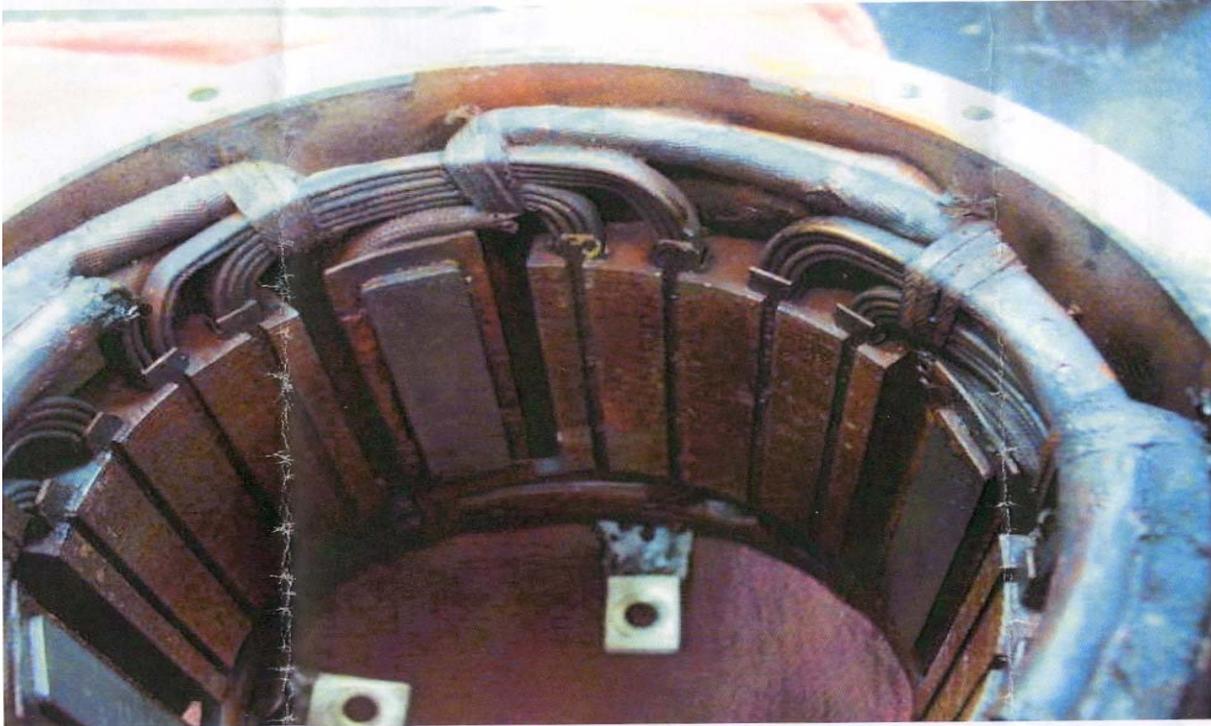
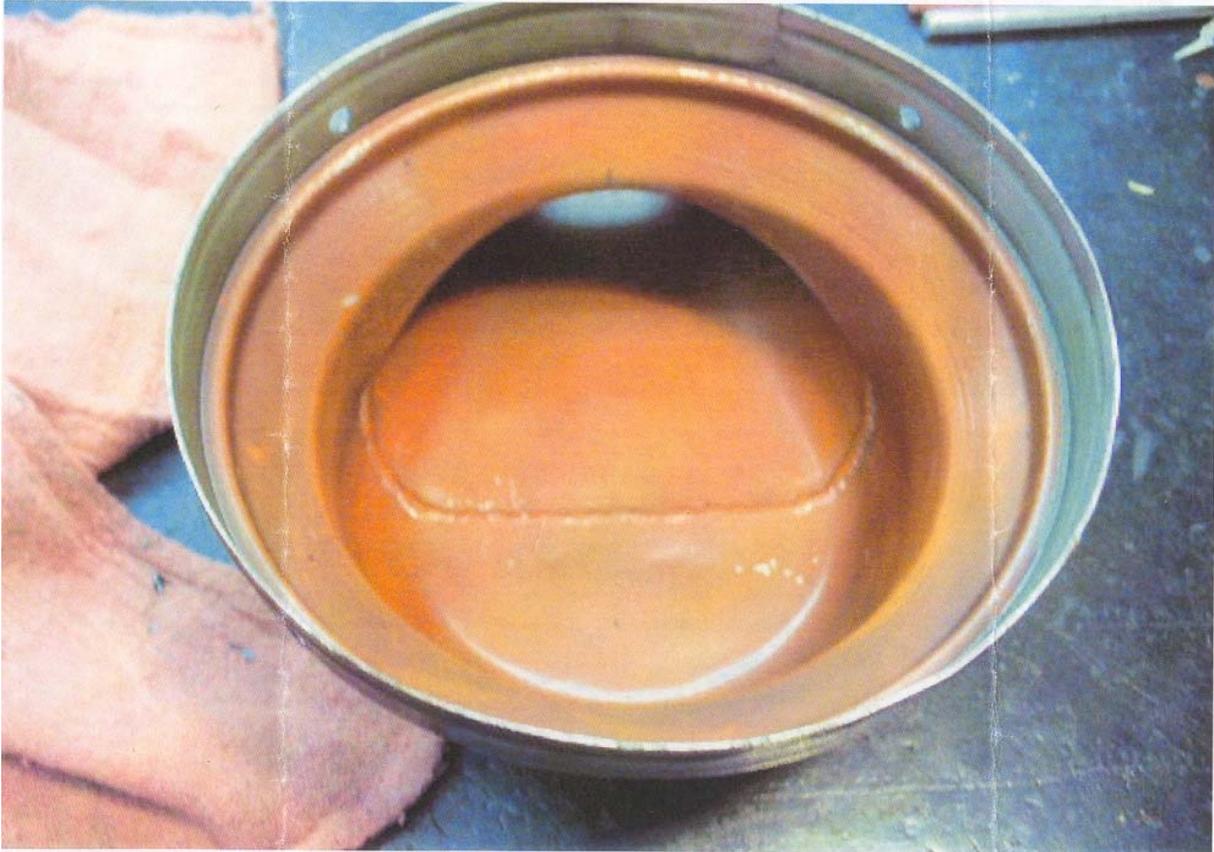
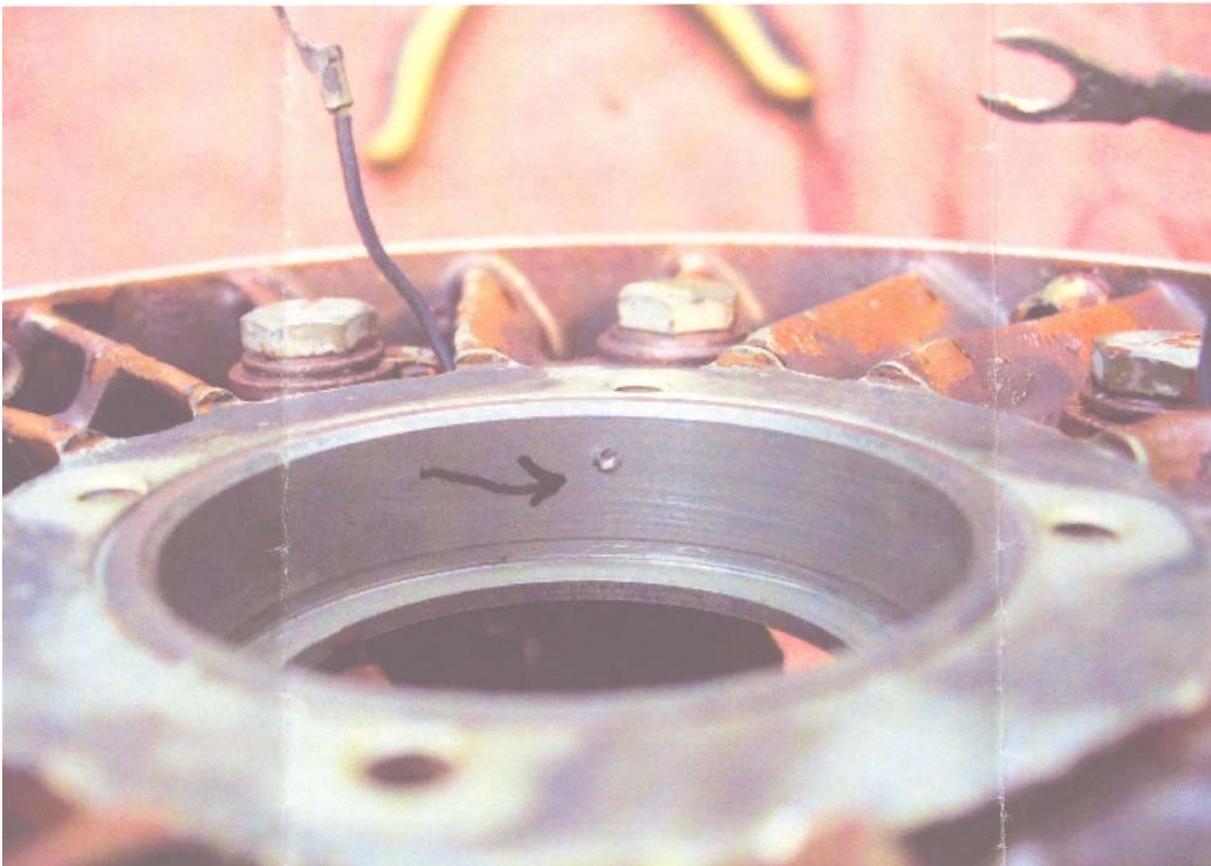
### **Goodrich: Starter/Generator; Improper Assembly; ATA 2435**

A repair station technician states, "During disassembly of this starter generator (P/N 23085-025) we received for routine overhaul, three items were noted that are not approved by the Goodrich 23085 Series, Revision 4, 8/12/2003, CMM 24-30-19 (*maintenance manual*). 1. The stator was coated with Glyptol paint. The CMM states 'The use of Glyptol on either the armature or stator windings is strictly prohibited. Units having Glyptol coating on either of these parts must have these parts replaced prior to returning the units to service.' 2. Glyptol was also found coating the inside of the air-scoop. This is not approved by Goodrich SPD 1002. 3. The Anti-Drive End Bearing Liner had been staked in two places, presumably to hold the bearing in place. This is not an approved practice according to the CMM. The liner must either be replaced or re-plated if the dimensions are not within tolerances.

"If the Goodrich CMM had been followed at the previous repair facility, these items would not have been an issue."

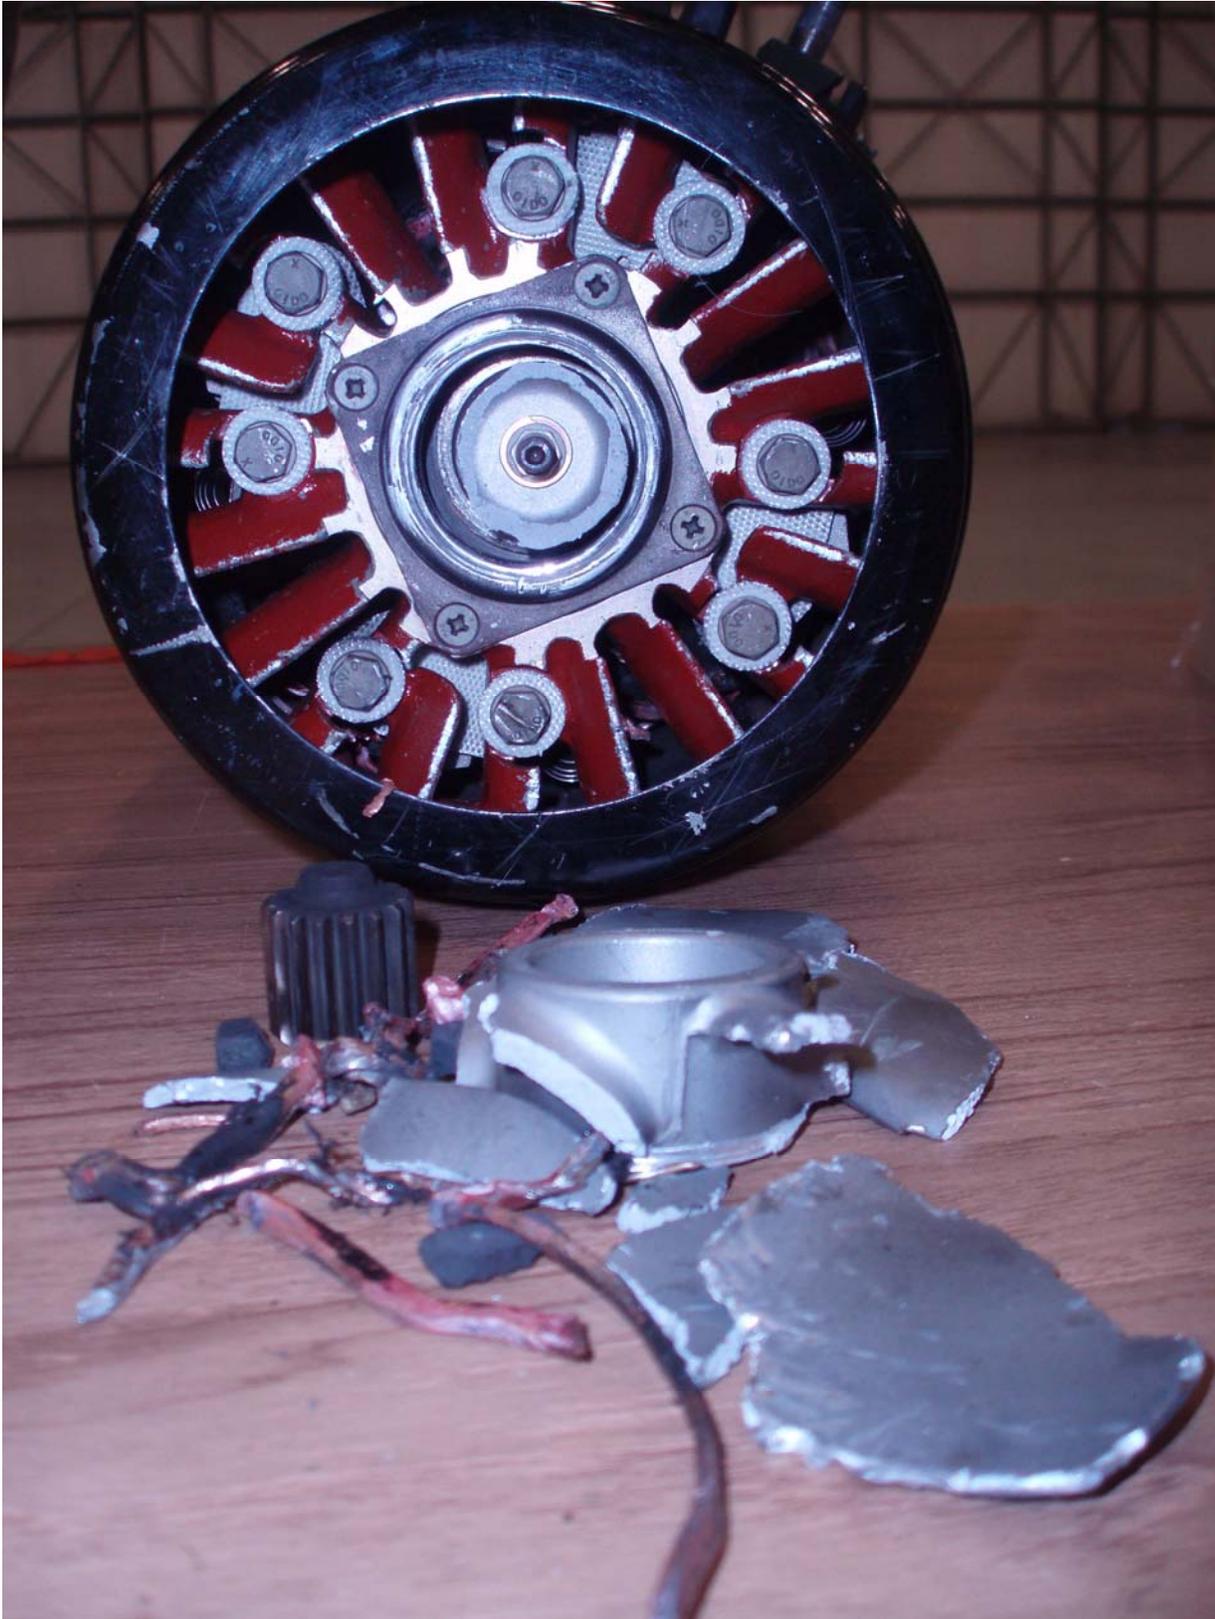
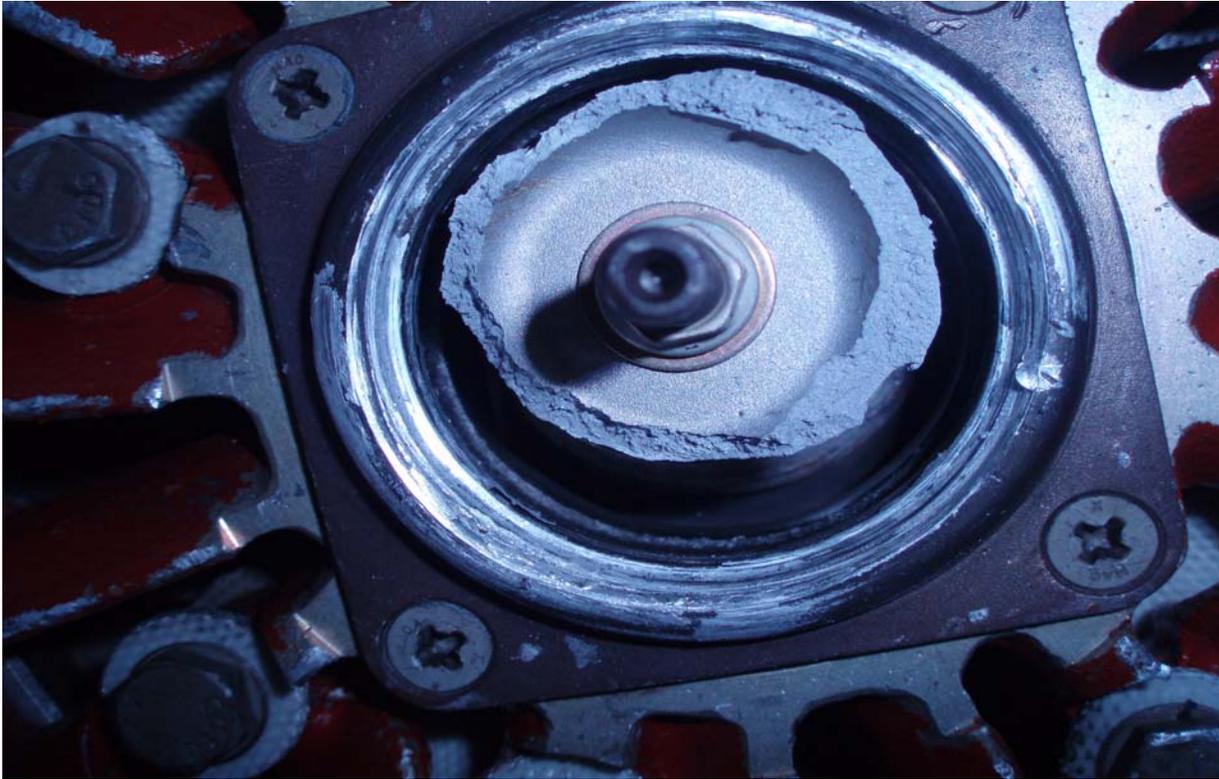
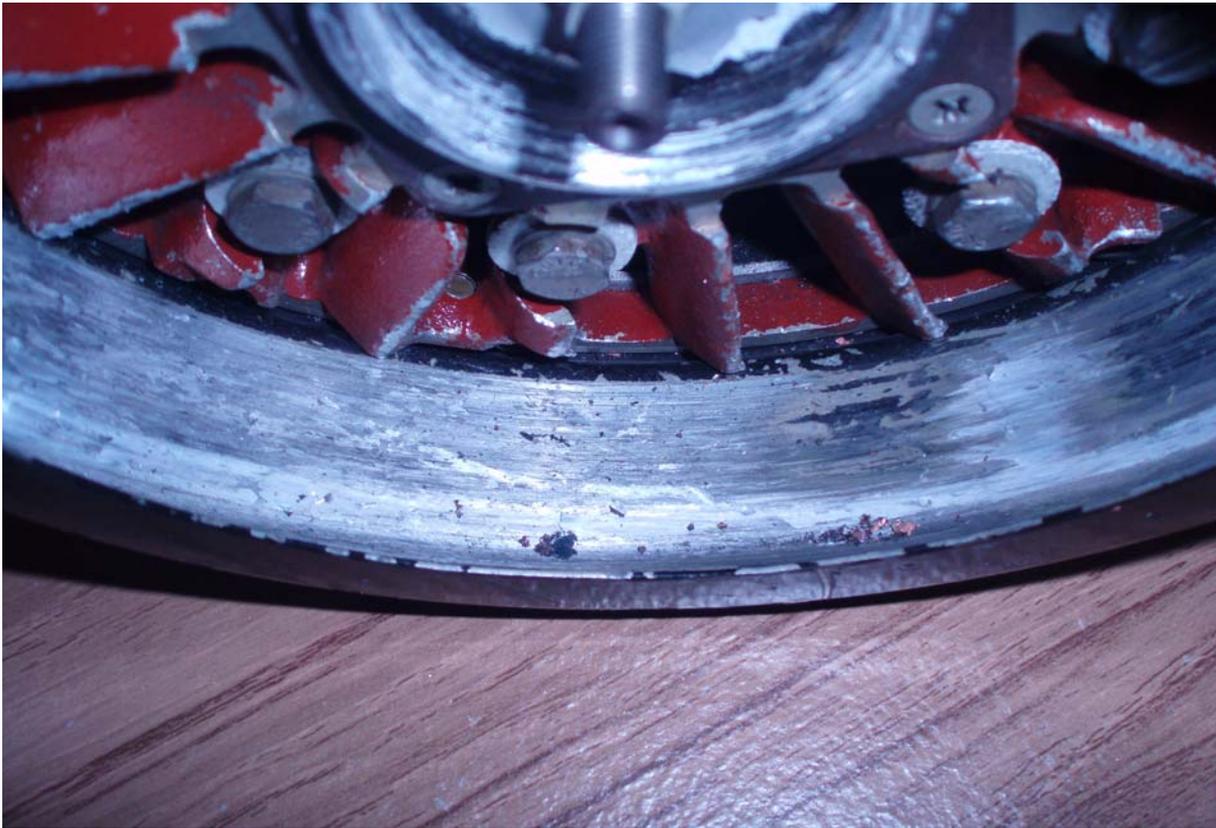
**TRW: Starter/Generator; Failed Cooling Fan; ATA 2435**

A technician writes, "During cruise flight (*the Hawker 1000 aircraft*) experienced vibration believed to (*originate*) from the engine area. The vibration increased (but did not show on the EVM indicator), followed by a generator number one fail indication with the bus tie closed. The aircraft made an unscheduled landing. Maintenance found the number one (*engine*) starter generator failed: the cooling fan on the generator shattered, and the shaft sheared—with many broken pieces of the unit in the engine cowling (*P/N 23091002*)."
