# Anatomy of a Switch Failure

**Anatomy of a Switch Failure:**

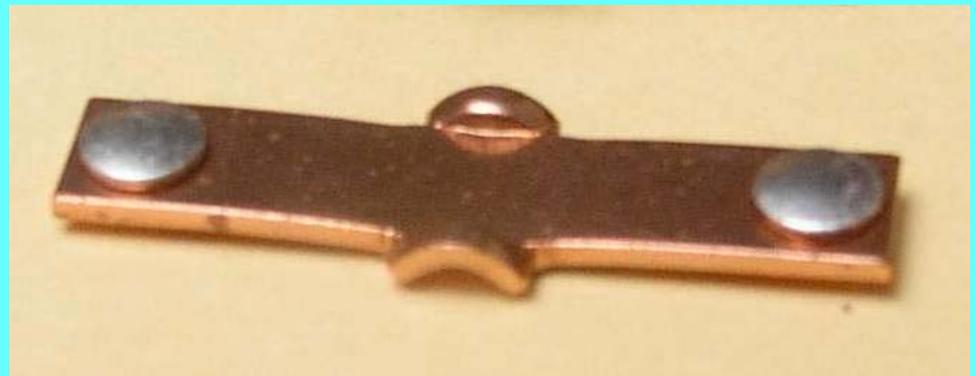
**Typical “teeter-totter” switch mechanism. Operating the toggle presses down on either side of the central pivot to rock the contact assembly**

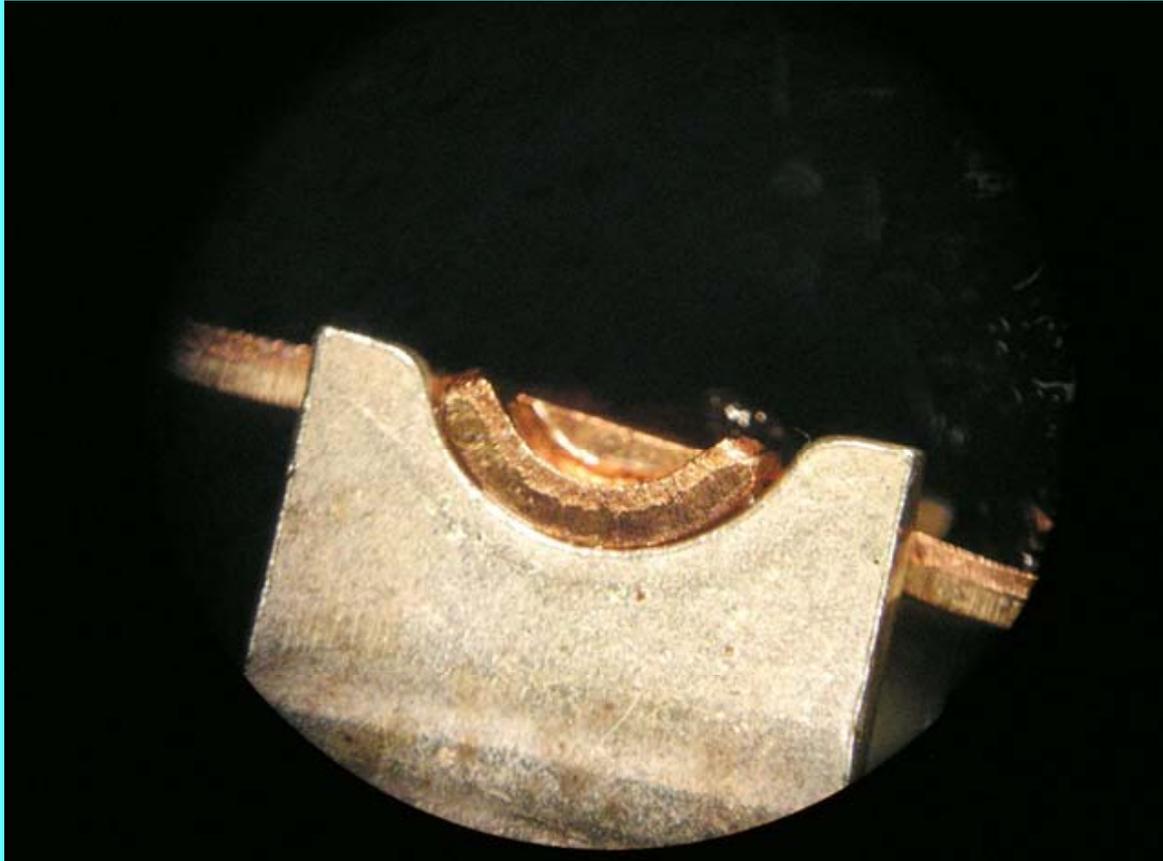
- The “teeter-totter” pivots on a cradle that is connected to the switch’s center terminal.
- The need for good electrical connection here is obvious

The switch in this case study would pop the supply fuse when the switch was turned OFF . . .

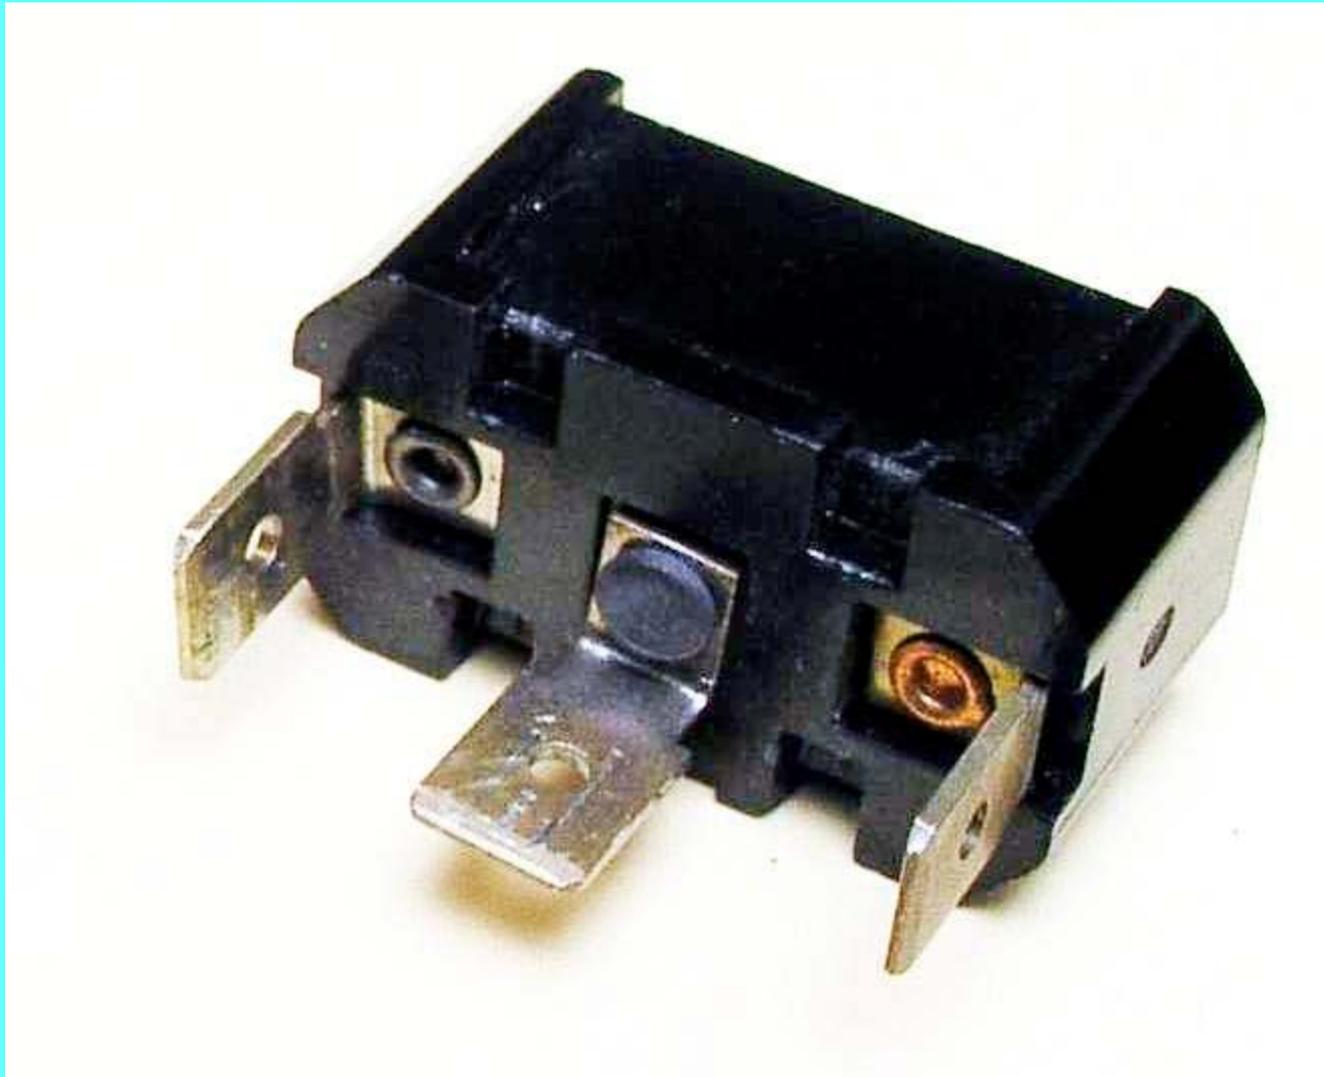
**Teeter-totter is sufficiently curved to allow OFF end of switch to rise against the grounded frame . . .**

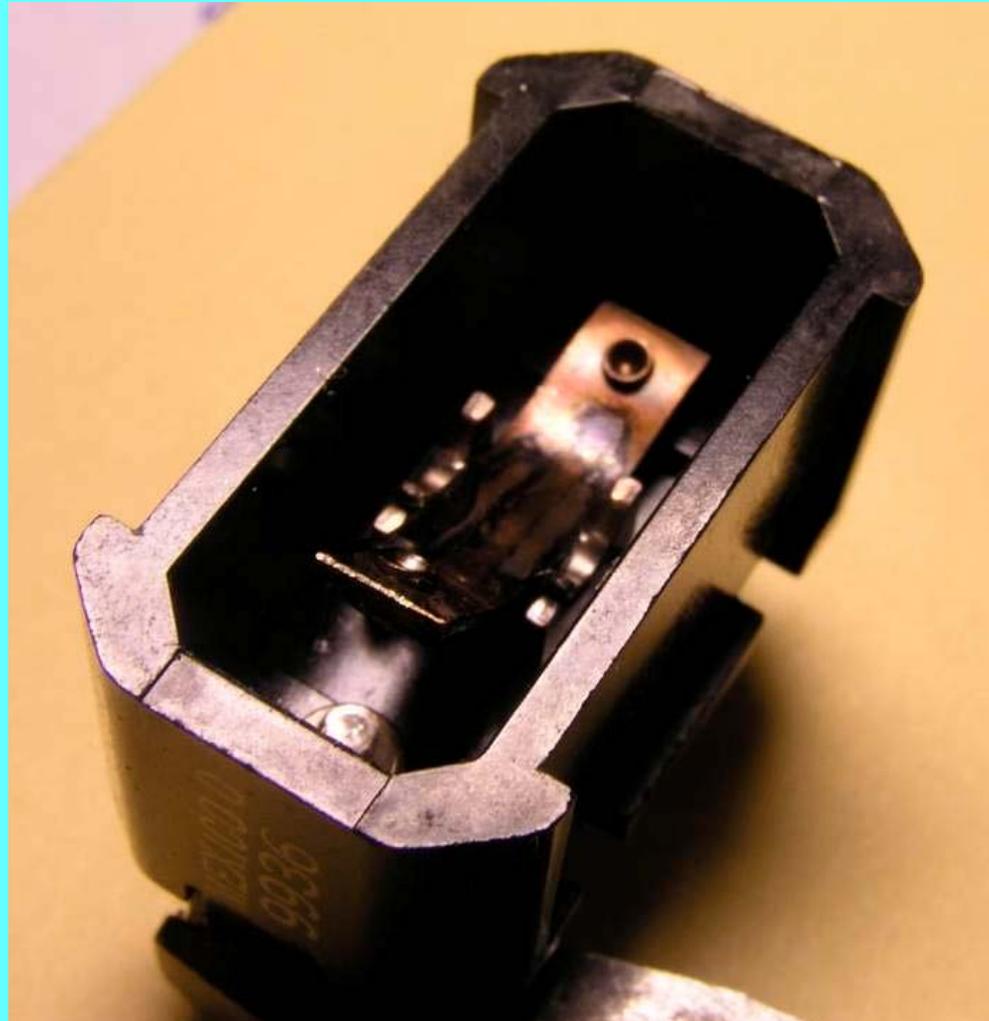
**Note bowed teeter-totter and burn mark on inside surface of frame . . .**

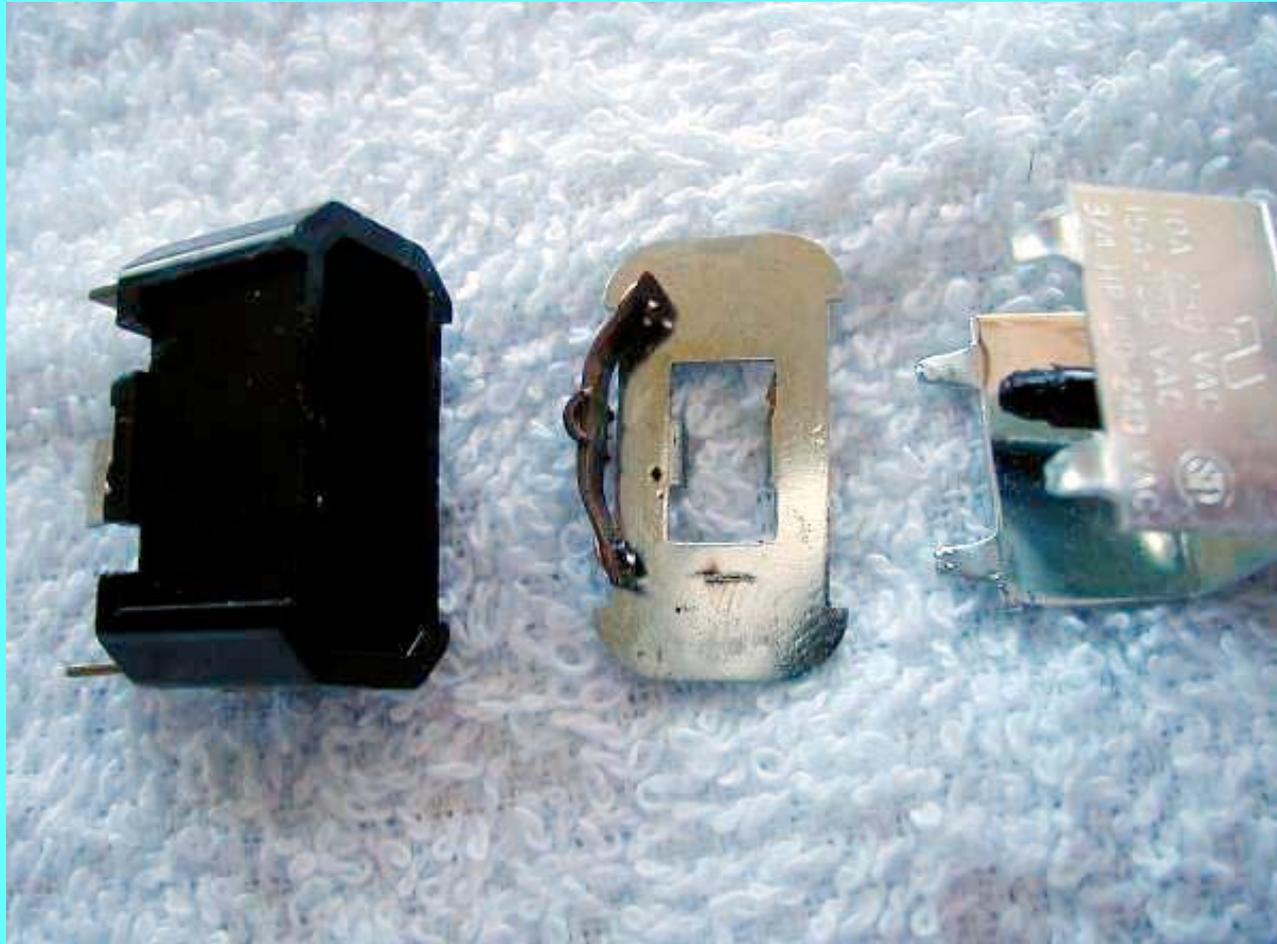
**The failed and a new teeter-totter . . .**

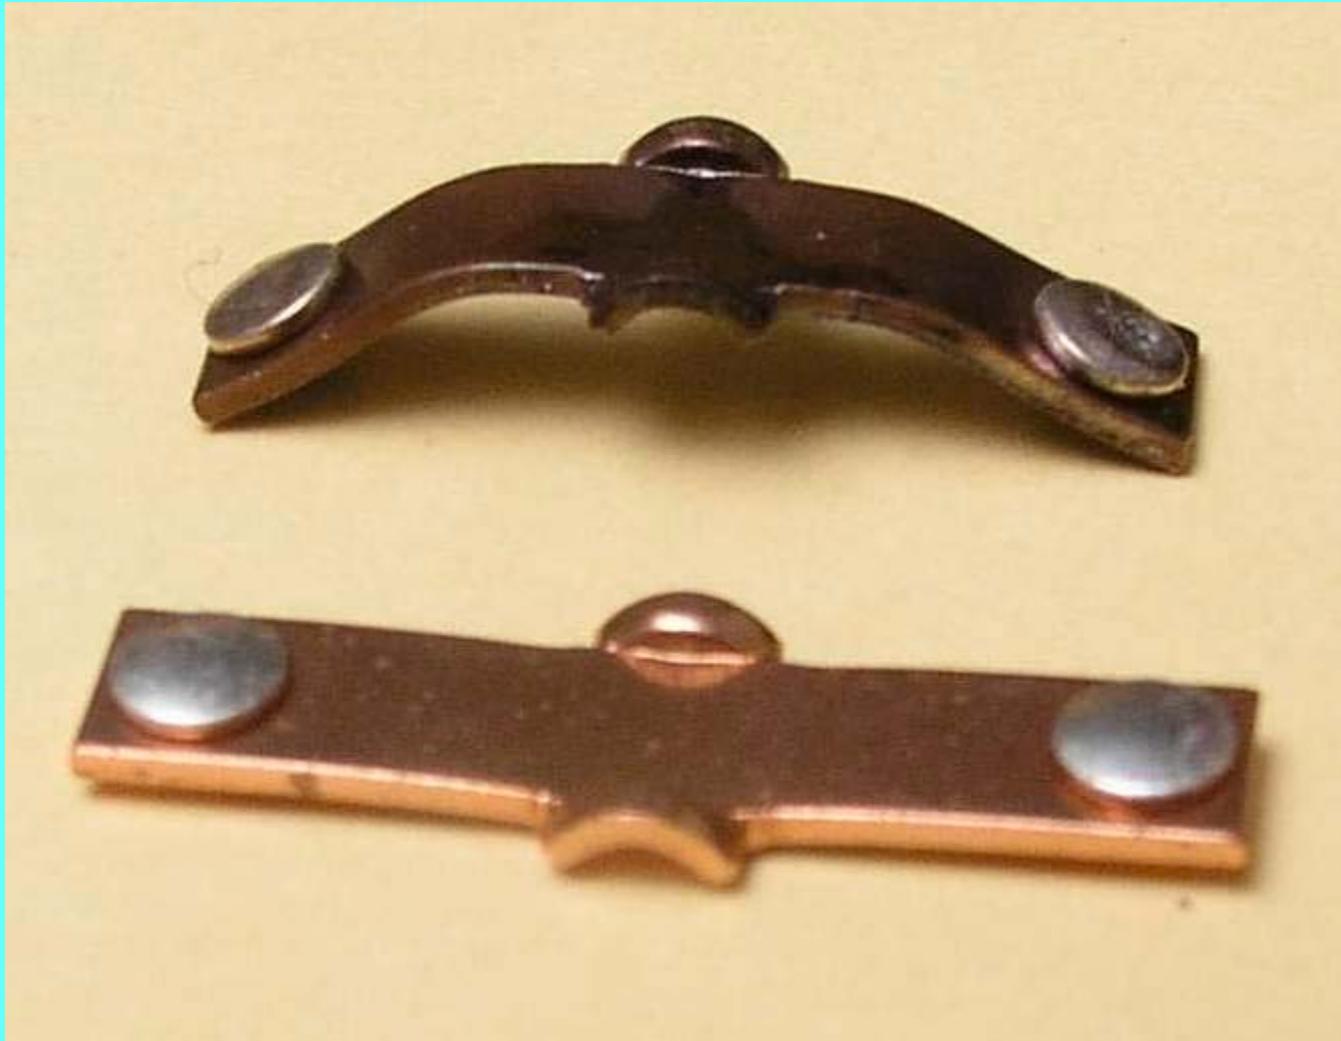
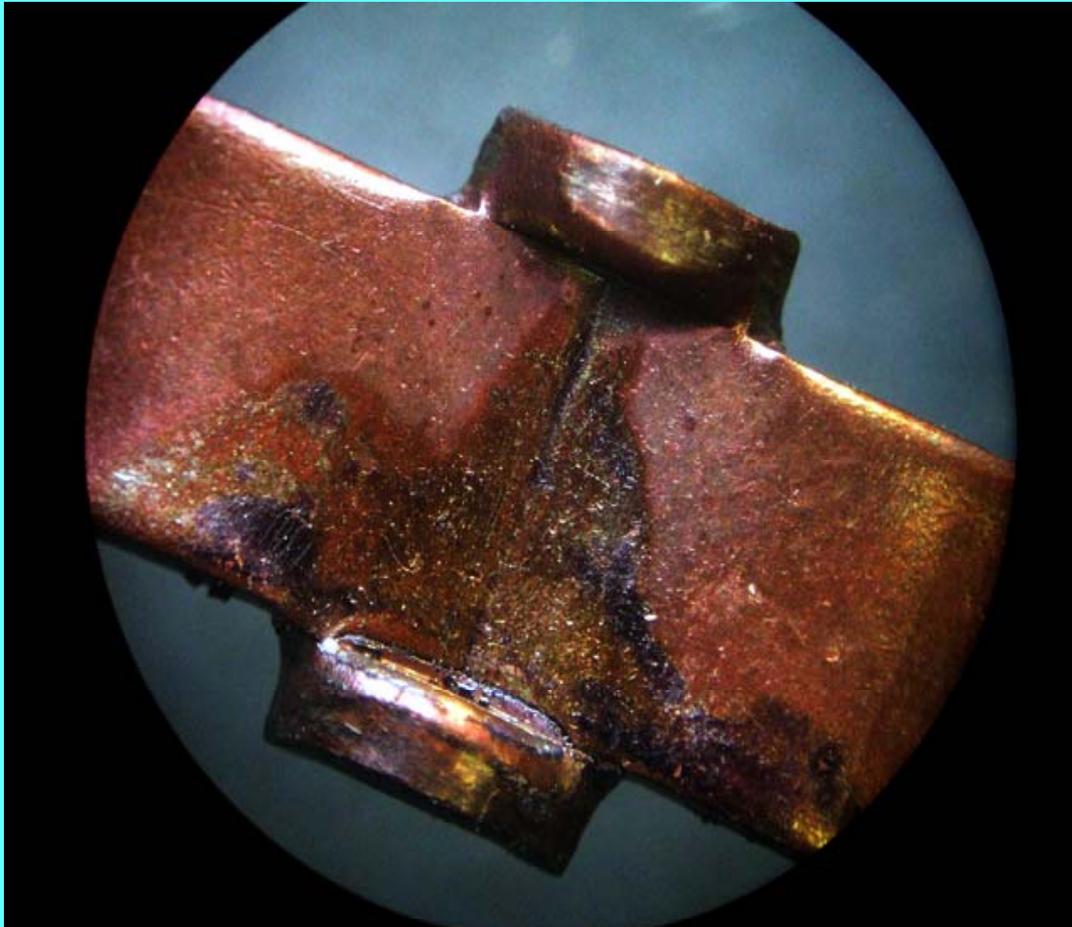
**The results of heating at the pivot point of the teeter-totter is evident.**

**The contacts for this switch were in excellent shape.**

**This switch was NOT overloaded. I was powering a strobe system with an average current draw under 5A.**

**Failure began at the upper pivot point which transferred all the load to the lower pivot and precipitated the heat-induced failure.**

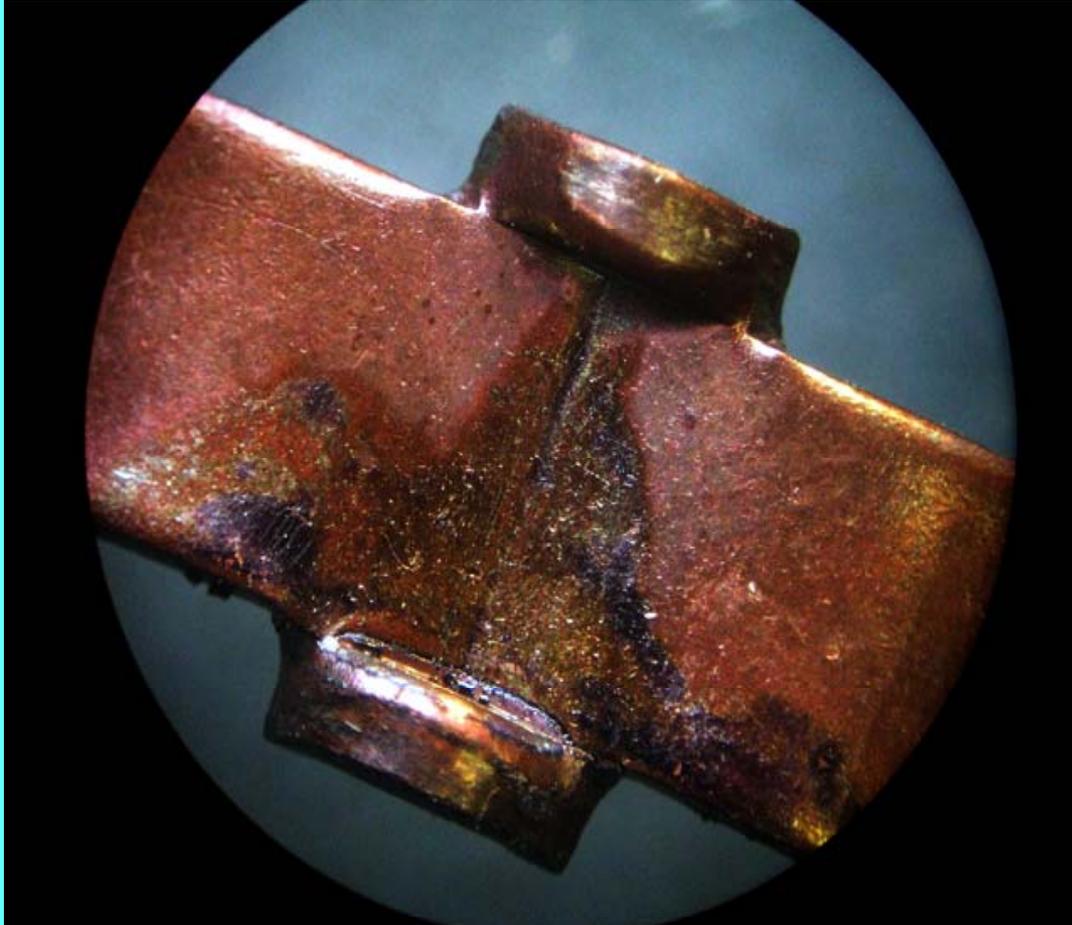
**A “high resistance” joint at the upper pivot pushed loads to the lower pivot point.**

**The lower pivot may have been suffering from the same elevated resistance phenomenon as the upper point. This exacerbated the failure event.**

**While the lower point was better able to shoulder the loads, localized heating provided the energy to soften the “teeter-totter” and allow the failure to progress forward with time.**

The teeter-totter was bent more on the OFF (non-current carrying ) side of the part.

This means that the part was being hammered more strongly in the transition from ON to OFF (hot) than during OFF to ON (cool).

This switch wasn't very old (a few hundred flight hours).

Failure started due to corrosion/poor fit at one pivot point. Heating at the over-loaded pivot caused precipitous increase in resistance that ultimately took the temper out of the material thus allowing it to change shape.

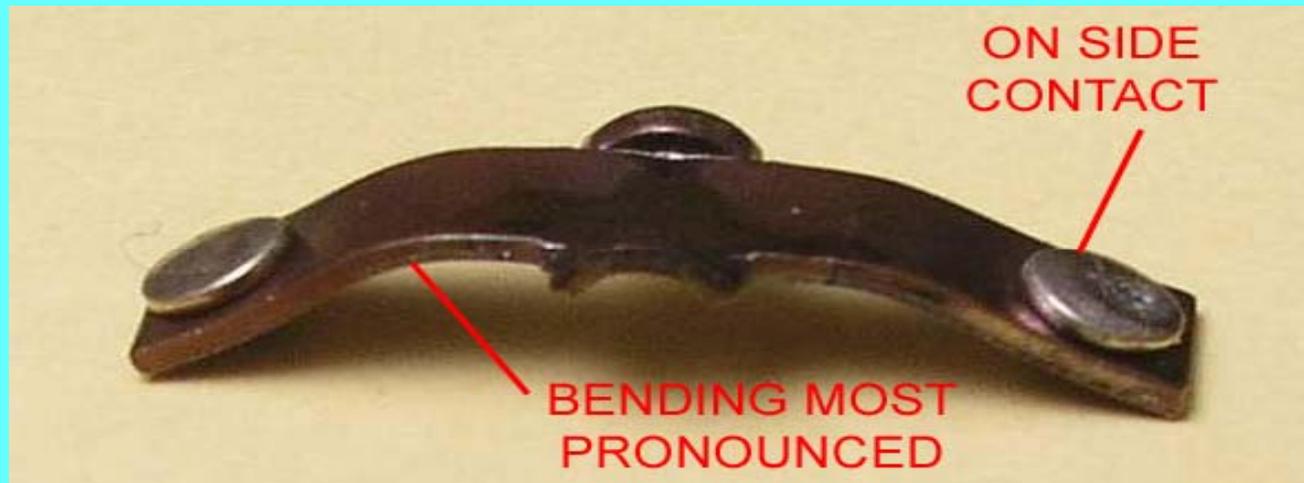
**This is an excellent example of a “high resistance” joint participating in a relatively slow degradation toward complete failure.**

**Had the terminals of the switch been reversed, ground in the OFF condition would not have blown the fuse. The contact degradation would have continued until the switch really “smoked”.**

**In this interesting but rare instance, the secondary failure of the teeter-totter coming to ground raised some flags that caused the switch to be replaced before it reach a catastrophic, smoke-generating failure.**
