### Smoke in the Cabin—Landing Light Switch Failure

*The following occurrence resulted in two aviation safety advisories from the Transportation Safety Board of Canada (TSB).*

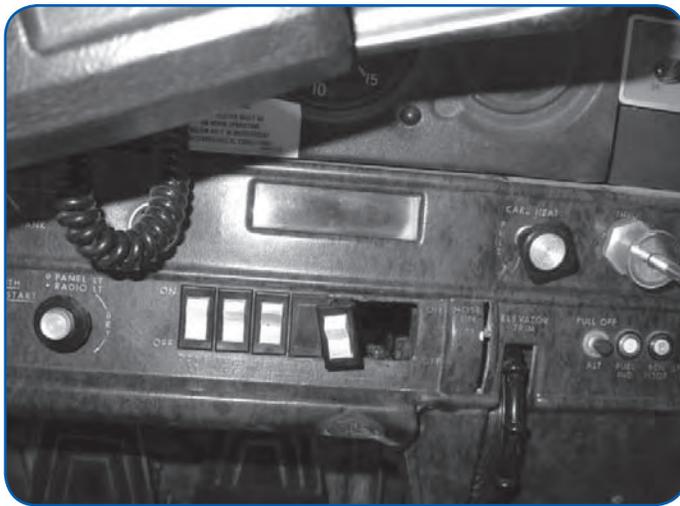
*Front of instrument panel*

On September 24, 2007, a Cessna 152 aircraft took off from the Oshawa Municipal Airport, Ont., with the pilot and passenger on board, destined to Kingston, Ont. Just after clearing the control zone, the pilot and passenger noticed an electrical odour and observed a small fire and smoke emanating from the bottom of the left dash panel where the aircraft lighting switches were located. The passenger, sitting in the right front seat, reached for and discharged the fire extinguisher. The fire was quickly extinguished, but the extinguishing agent clouded the cockpit, reducing visibility. The cockpit windows were opened and visibility improved considerably. The aircraft returned to the Oshawa airport and landed without further incident. The pilot suffered a minor burn to his leg when the plastic instrument panel melted and dripped onto his jeans. The TSB issued Final Report A07O0264 on January 14, 2009, regarding this occurrence.

The TSB determined that the landing light switch installed in the occurrence aircraft was beyond its design capability and therefore was unsuitable for the circuit it was controlling. Excessive heat from arcing and oxidization within the switch weakened the switch structure and contact support, allowing the contacts to fall out or be exposed. Arcing from the contacts caused oil residue to flash, which ignited a nearby dust accumulation and started the fire. Combustion was sustained by the plastic instrument panel. The TSB stated that similar landing light switch systems are incorporated on most

of the Cessna 100-series aircraft, thereby increasing the likelihood of a similar event. The TSB issued two aviation safety advisories as a result of their investigation.

The TSB suggested that Transport Canada (TC), in co-ordination with the FAA and the aircraft manufacturer, may wish to take action to mitigate or eliminate the threat of fire caused by AC-rated switches in the landing light DC circuit of Cessna 152 aircraft.

The FAA took action to mitigate or eliminate the threat of fire caused by AC-rated switches in the landing light DC circuit of Cessna 152 aircraft. Cessna co-operated with the FAA by issuing Mandatory Service Bulletins MEB09-3 and SEB09-6 dated May 11, 2009, to remove and replace all subject switches used in the landing light as well as the taxi light and rotating beacon circuits in the 100-, 200- and 300-series Cessna models with service life greater than four years. This includes the Cessna 152-series aircraft. These bulletins are to be accomplished within the next 400 hours of operation, or 12 calendar months, whichever comes first. A review of the database shows less than 1 percent of the fleet has been affected by this type of failure. Therefore, the FAA's course of action has been to disseminate the concern by issuing a Special Airworthiness Information Bulletin (SAIB) CE-09-42, which is available at [www.faa.gov/aircraft/safety/alerts/SAIB/](http://www.faa.gov/aircraft/safety/alerts/SAIB/).

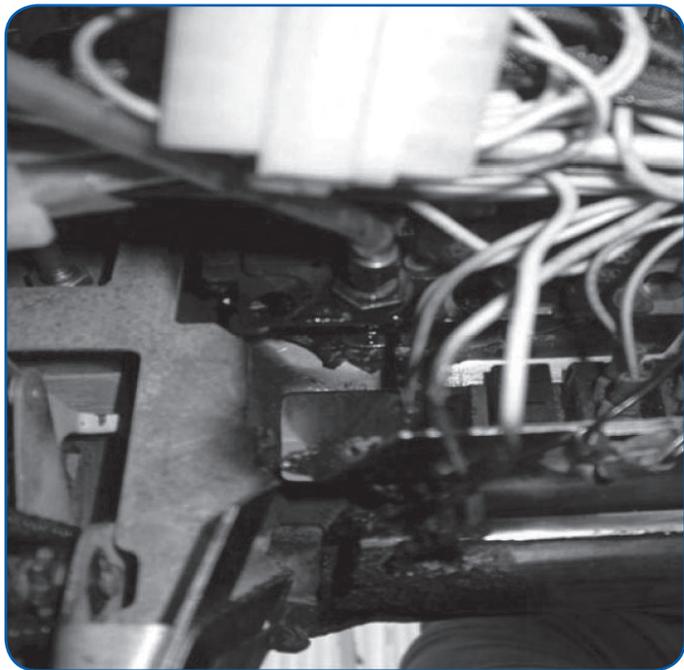
Rear of instrument panel

The switch was identified as a rocker-style switch rated at 10A 250VAC, 15A 125VAC, 3/4HP125-250 VAC. No DC ratings were found for this switch. The switch showed evidence of melt damage beginning at the base and progressing upward on both sides. The same damage was evident on the interior of the switch. The switch exterior had a thick coating of dust and an oily residue, which was also found inside the switch. A scanning electron microscope (SEM) and energy dispersive spectroscopy (EDS) analysis of the residue indicated that it might have been engine oil.

The landing light circuit wires remained attached to the contact but showed evidence of fire damage near where the contact enters the switch. The contact was coated with the plastic casing material and when the surface was examined there was evidence of repeated arcing, which had severely eroded the contact's surface. Arcing within the landing light switch could have provided the ignition source necessary for a fire to start. The dust covering evident on the switch and the oil residue provided by possible seepage from the oil pressure gauge line located above the switch may have provided the kindling necessary to start a fire. The oil would consistently reach its flash point when exposed to arcing, and when it was in proximity to the dust it would cause the dust to ignite. A small section of the plastic instrument panel was tested for flammability by introducing a direct flame to the

plastic. The piece of panel readily ignited and sustained flame. It also produced gases that were quite harsh when inhaled, and without sufficient ventilation may cause some incapacitation to the pilot.

According to the U.S. Federal Aviation Administration (FAA) Advisory Circular 43.13-1B, chapter 11 (pages 11–17), because of the initial current encountered by switches controlling 28 VDC lamp loads (incandescent lamps), the switches should have a derating factor of 8. This aircraft's switch controls a 250-watt lamp in a circuit powered by 28 VDC, and should have a minimum DC current rating of 71 amps. The switch from the aircraft had an AC rating. The Advisory Circular has a warning that reads “Do not use AC derated switches in DC circuits. AC switches will not carry the same amperage as a DC switch.” The switch manufacturer was contacted and provided with the landing light circuit and switch information. After evaluating the information, they confirmed that the switch was not designed to handle the lamp loads described.
