# Anatomy of a Switch Failure

**Anatomy of a Switch Failure:**

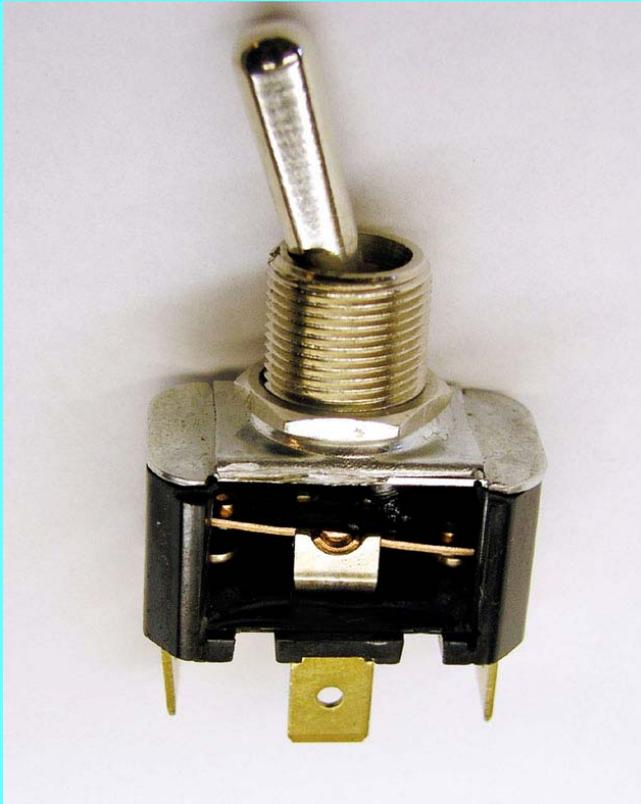
**Typical “teeter-totter” switch mechanism. Operating the toggle presses down on either side of the central pivot to rock the contact assembly**

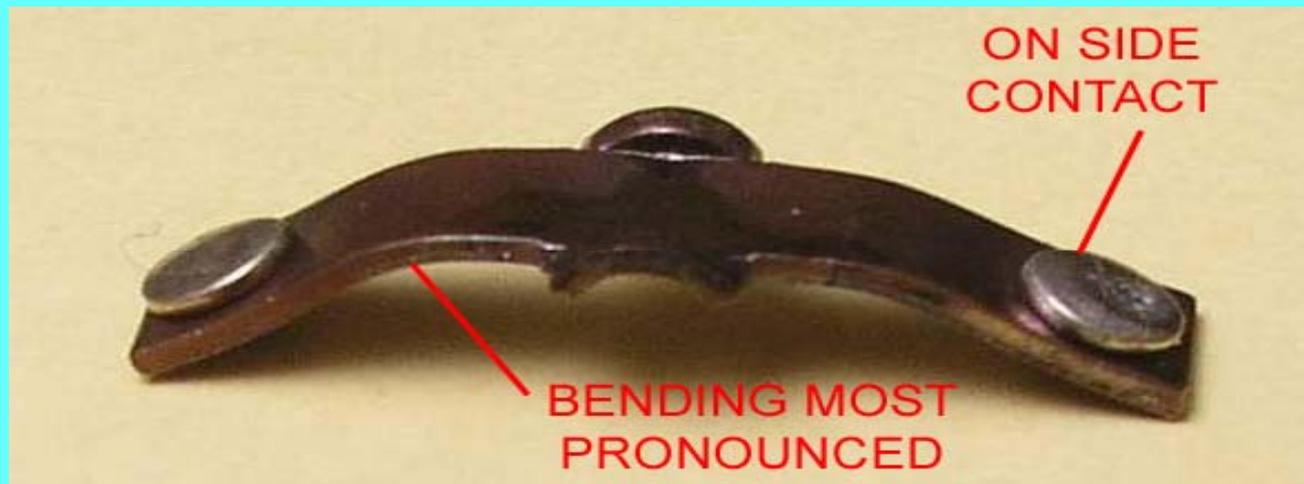
**This is an excellent example of a “high resistance” joint participating in a relatively slow degradation toward complete failure.**

**Had the terminals of the switch been reversed, ground in the OFF condition would not have blown the fuse. The contact degradation would have continued until the switch really “smoked”.**

**In this interesting but rare instance, the secondary failure of the teeter-totter coming to ground raised some flags that caused the switch to be replaced before it reach a catastrophic, smoke-generating failure.**
